Cisco ONS 15530 Troubleshooting Guide

Cisco IOS Release 12.2 SV
February 2006

Text Part Number: OL-9544-01

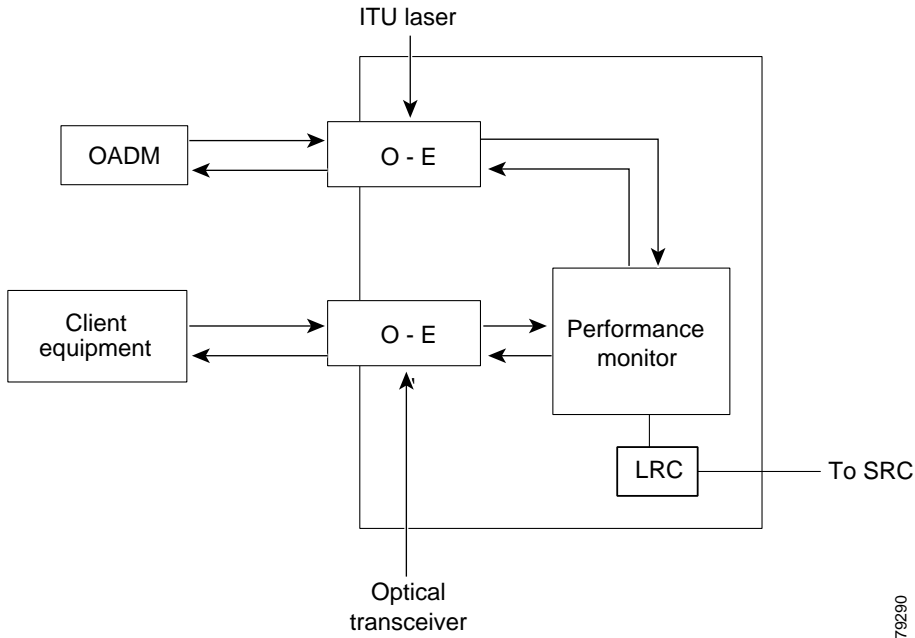
Figure 3-1 Transponder Line Card Architecture

Figure 3-1 and Figure 3-2 show the architecture and the interfaces of the transponder line card.

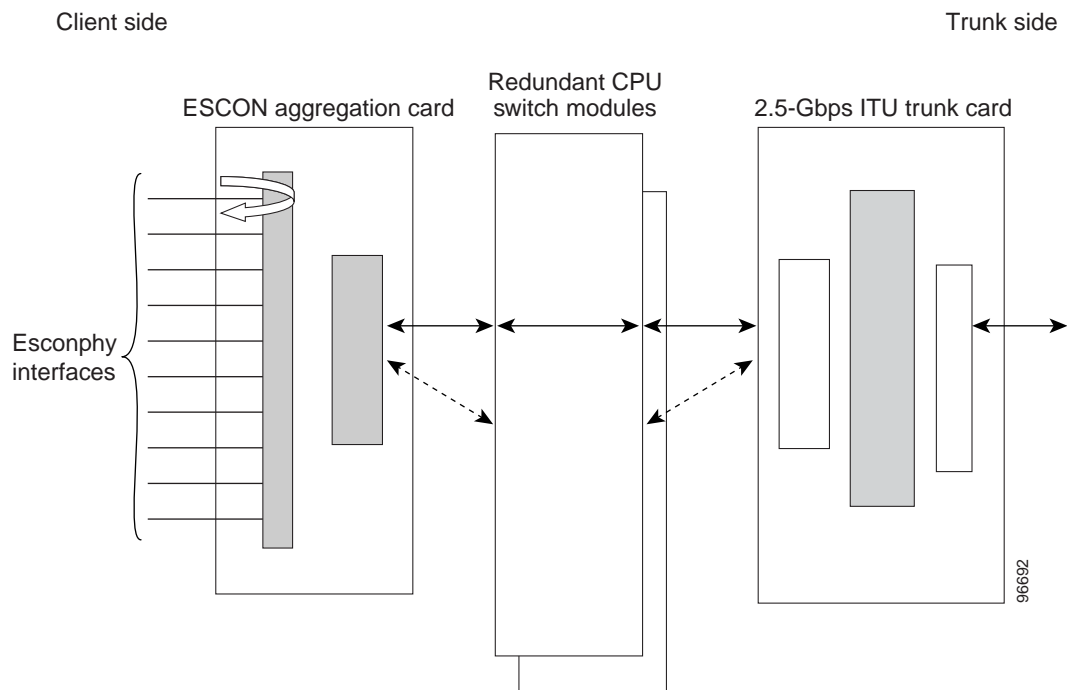
Figure 4-2 Client Signal Loopback Example

Client signal loopbacks on ESCON aggregation cards verify the functioning of the SFP optics (see Figure 4-2).

-
- Step 1** Issue a **loopback** command on the esconphy interface.
 - Step 2** Check that the traffic is reaching the client equipment.

Step 3 If the signal does not reach the client equipment, check the optical cables for breaks. If there are no breaks, replace the SFP optics.

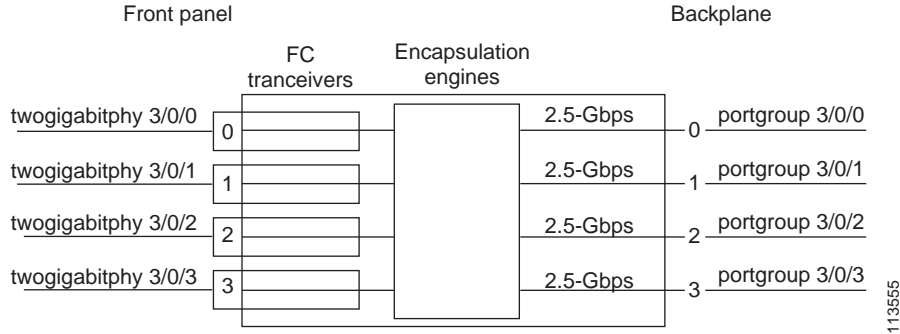
Figure 5-1 Interfaces for a 4-port 1-Gbps/2-Gbps FC Aggregation Card

Figure 5-1 shows an example path of a client signal through the Cisco ONS 15530 and the associated interfaces.

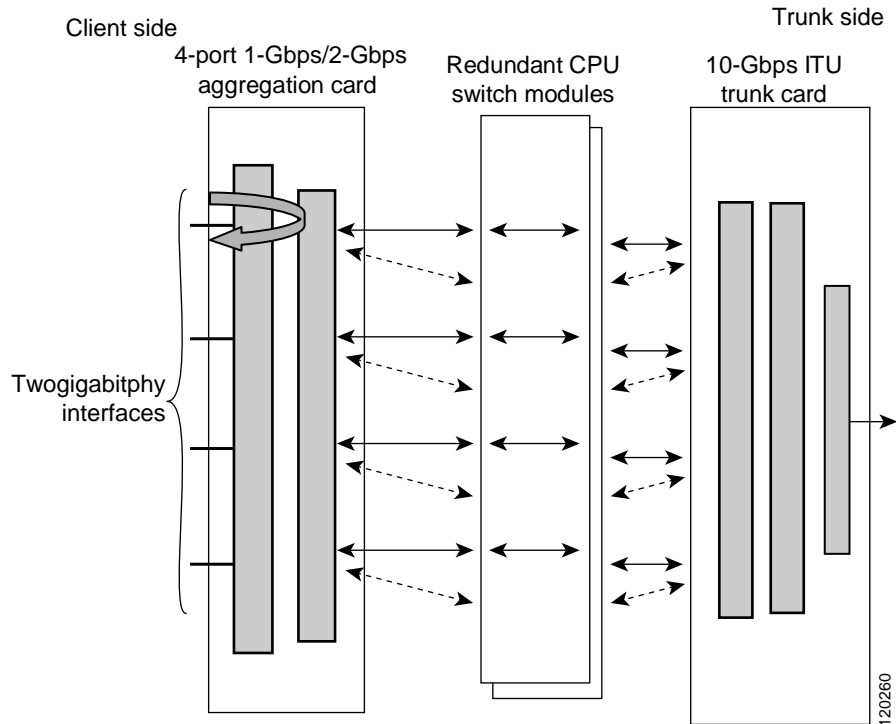
Figure 5-2 Facility Loopback Example

Facility loopbacks on 4-port 1-Gbps/2-Gbps FC aggregation cards verify the functioning of the SFP optics from the client side (see Figure 5-2).

-
- Step 1** Issue a **loopback facility** command on the twogigabitphy interface.
 - Step 2** Check that the traffic is reaching the client equipment.
 - Step 3** If the signal does not reach the client equipment, replace the SFP optics.
-

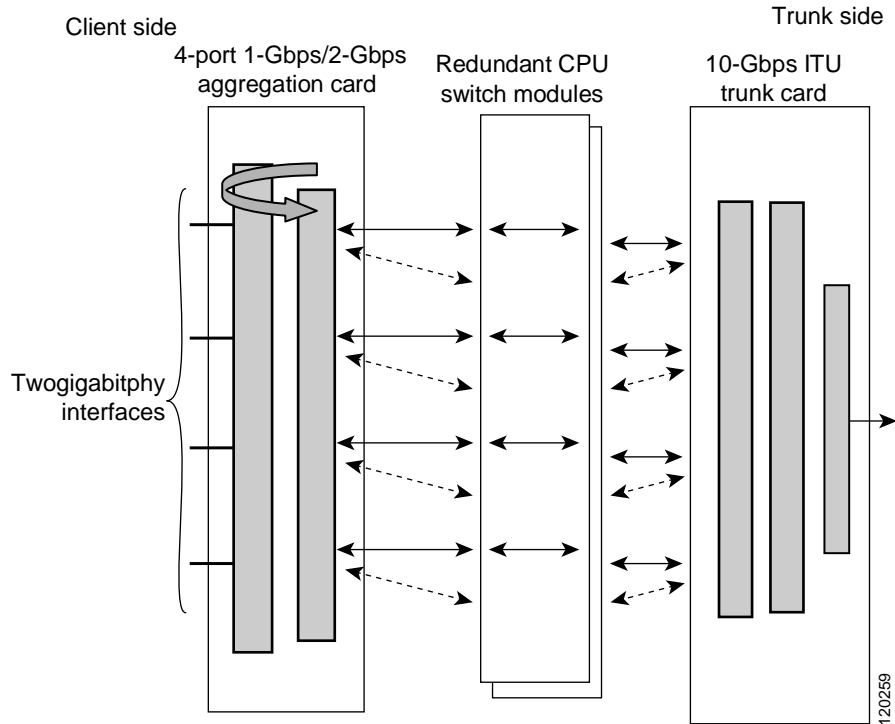
Figure 5-3 Terminal Loopback Example

Terminal loopbacks verify the functioning of the 4-port 1-Gbps/2-Gbps FC aggregation cards from the trunk side (see Figure 5-3).

-
- Step 1** Issue a **loopback terminal** command on the twogigabitphy interface.
 - Step 2** Check that the traffic is reaching the client equipment.
 - Step 3** If the signal does not reach the far end, check the trunk fiber and the interfaces along the signal path. If the fiber is intact, replace the card.
-

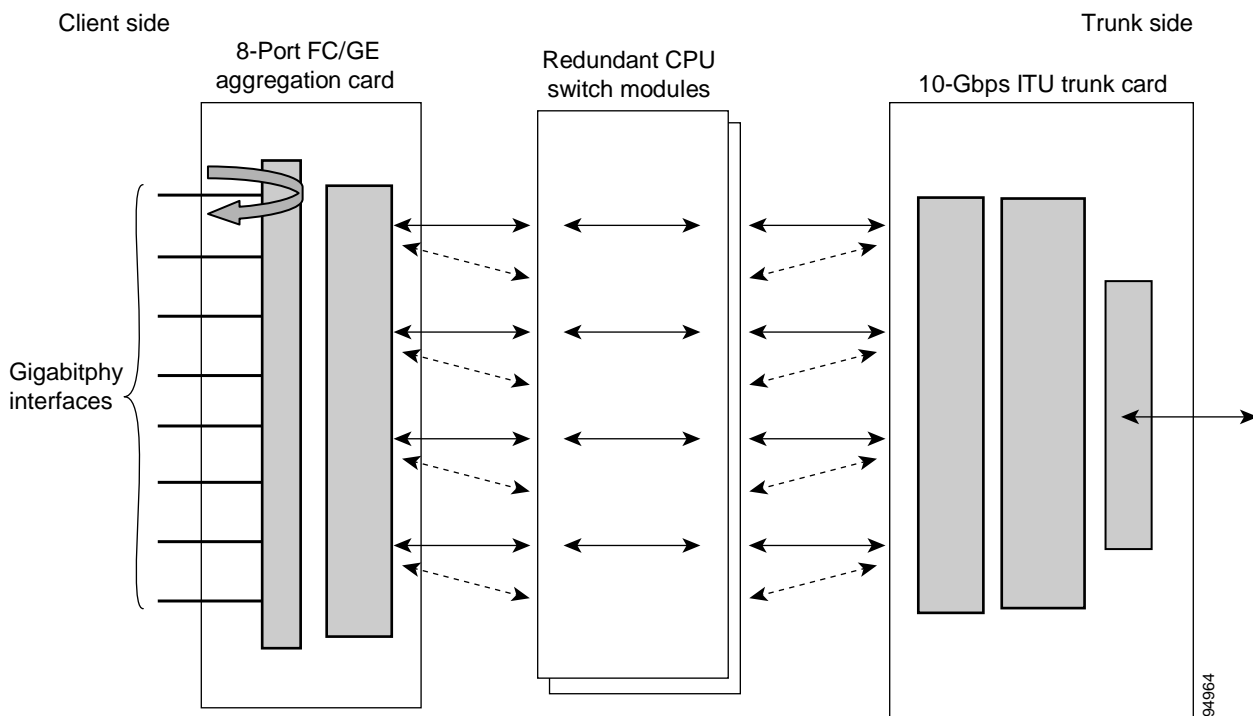
Figure 6-2 Facility Loopback Example

Facility loopbacks on 8-port FC/GE aggregation cards verify the functioning of the SFP optics from the client side (see Figure 6-2).

- Step 1** Issue a **loopback facility** command on the gigabitphy interface.
- Step 2** Check that the traffic is reaching the client equipment.

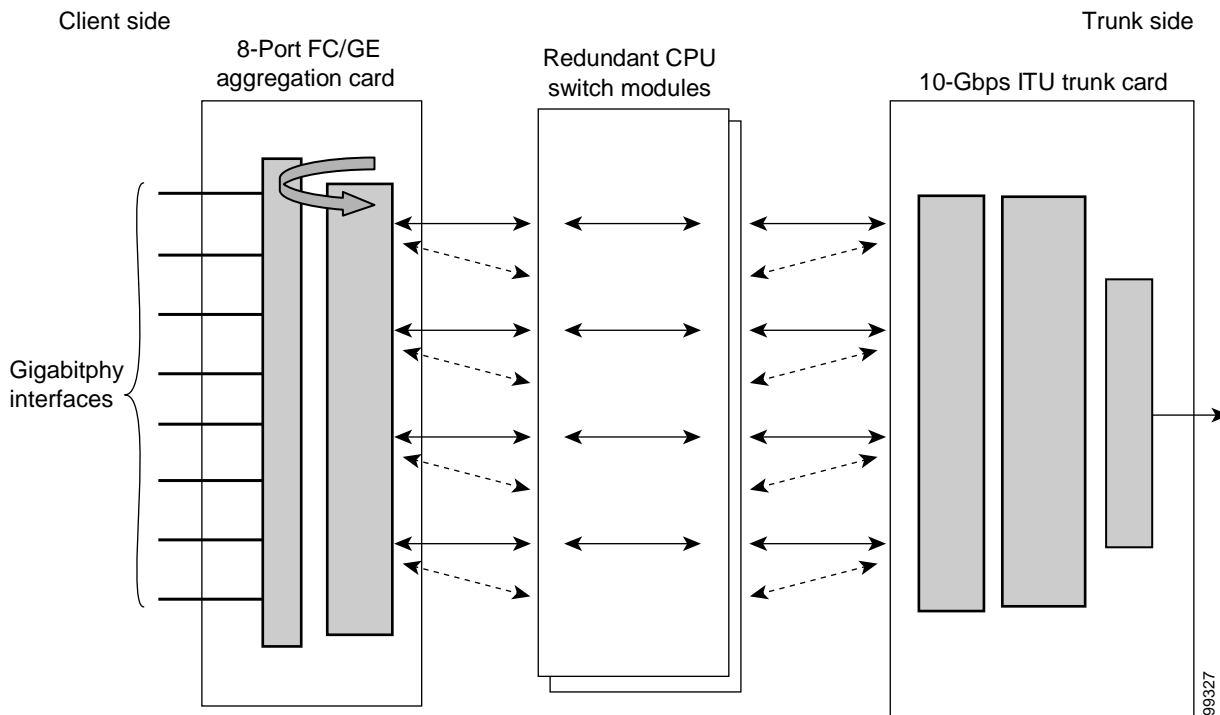
Figure 6-3 Terminal Loopback Example

Terminal loopbacks verify the functioning of the 8-port FC/GE aggregation cards from the trunk side (see Figure 6-3).

- Step 1** Issue a **loopback terminal** command on the gigabitPHY interface.
- Step 2** Check that the traffic is reaching the client equipment.
- Step 3** If the signal does not reach the far end, check the trunk fiber and the interfaces along the signal path. If the fiber is intact, replace the card.

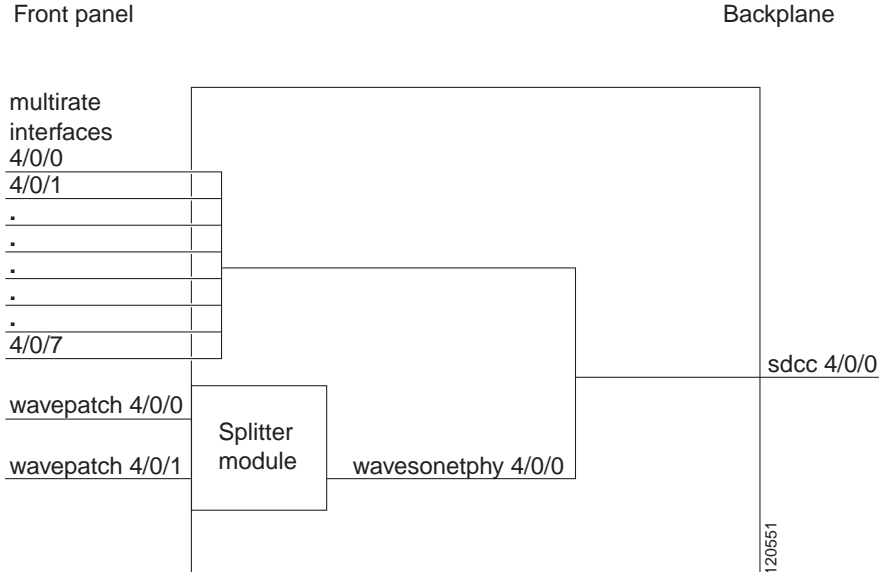
Figure 7-1 8-Port Multi-Service Muxponder Interfaces (Splitter Shown)

Figure 7-1 shows the interfaces of the 8-port multi-service muxponder.

Although the 8-port multi-service muxponder uses a SONET-like framing structure to aggregate multiple client data streams, it is not SONET compliant on the optical trunk output. The muxponder ITU compliant optical trunk output must be used in an end-to-end configuration and cannot be connected to a SONET/SDH OADM.

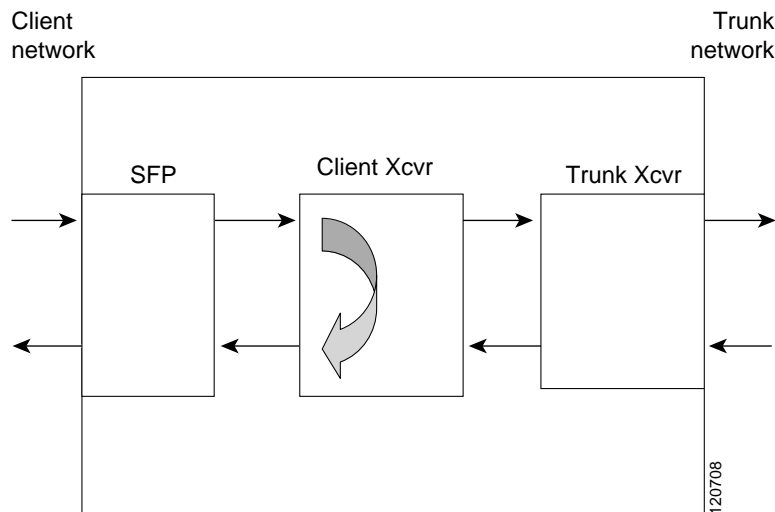
Figure 7-2 Client-Side Facility Loopback Example

Client-side facility loopbacks on 8-port multi-service muxponders verify the functioning of the SFP optics from the client side (see Figure 7-2).

For T1 and E1 encapsulations the loopback is performed on the SFP, not the client Xcvr.

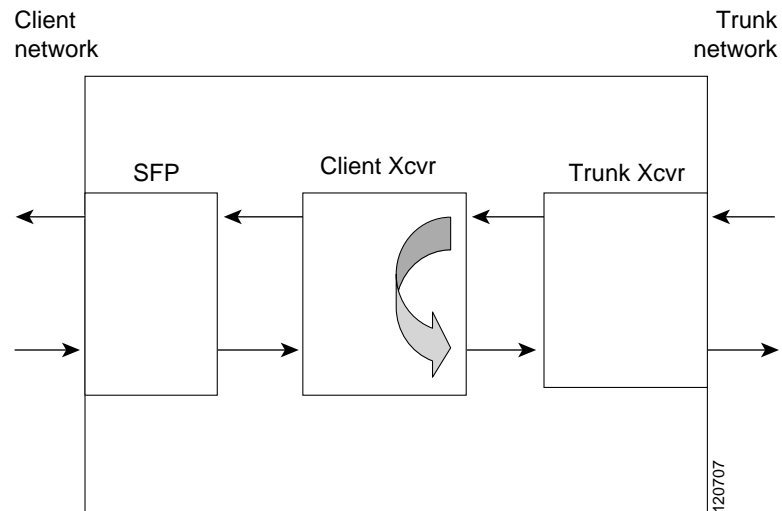
Figure 7-3 Client-Side Terminal Loopback Example

Client-side terminal loopbacks verify the functioning of the 8-port multi-service muxponders from the trunk side (see Figure 7-3).

Note For T1 and E1 encapsulations the loopback is performed on the SFP, not the client Xcvr.

- Step 1** Issue a **loopback terminal** command on the multirate interface.
- Step 2** Check that the traffic is reaching the remote client equipment.
- Step 3** If the signal does not reach the far end, check the trunk fiber and the interfaces along the signal path. If the fiber is intact, replace the 8-port multi-service muxponder.

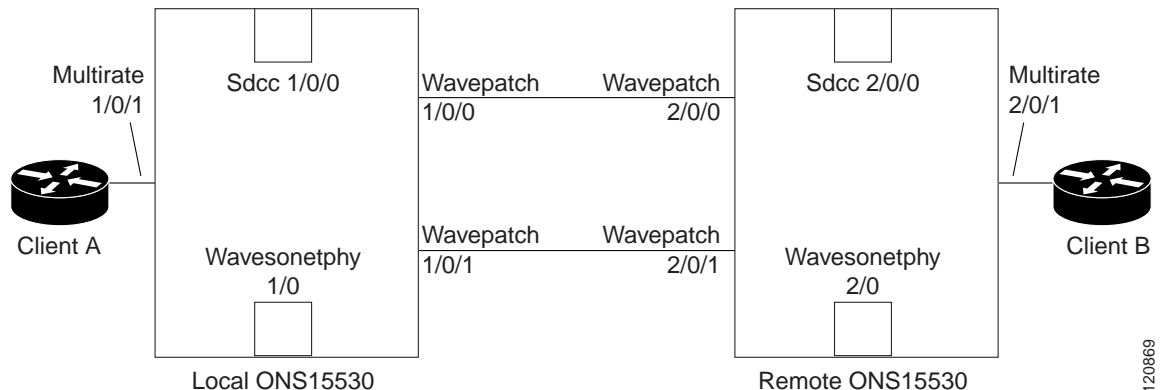
Figure 7-6 8-Port Multi-Service Muxponders in an End-to-End Configuration

Figure 7-6 shows an example of 8-port multi-serve muxponders connected end-to-end. The following procedure describes the process of troubleshooting protocol level errors (for example, CRC errors on a Fastethernet interface) using loopbacks. Assume that the trunk connection between wavepatch 1/0/0 and wavepatch 2/0/0 is active.

-
- Step 1** Issue a **loopback facility** command on multirate interface 1/0/1 of client A. Verify that traffic comes back to client A without errors. If errors are seen, one of the following may be the cause:

- Client A itself is sending traffic with errors.
 - The optical connectors between client A and the local Cisco ONS 15530 are dirty or need to be replaced.

- The SFP on the multirate interface is faulty.
- If no errors occur, proceed to Step 2.
- Step 2** Issue a **no loopback facility** command on multirate interface 1/0/1 of the local Cisco ONS 15530, and issue a **loopback terminal** command on wavesonetphy 1/0 of the local Cisco ONS 15530. If errors occur, replace the 8-port multi-service muxponder. If no errors occur, proceed to Step 3.

- Step 3** Issue a **no loopback terminal** command on wavesonetphy 1/0 of the local Cisco ONS 15530 and issue a **loopback facility** command on wavesonetphy 2/0 on the remote Cisco ONS 15530. If errors are seen on client A, one of the following may be the cause:

- The optical connectors between the local Cisco ONS 15530 and the remote Cisco ONS 15530 are dirty or need to be replaced.
 - The 8-port multi-service muxponder on the remote Cisco ONS 15530 is faulty.

- If no errors occur, proceed to Step 4.
- Step 4** Issue a **no loopback facility** command on wavesonetphy 2/0 of the remote Cisco ONS 15530, and issue a **loopback terminal** command on multirate 2/0/1 on the remote Cisco ONS 15530. If errors are seen on client A, replace the 8-port multi-service muxponder in the remote Cisco ONS 15530. If no errors occur, proceed to Step 5.

- Step 5** Issue a **loopback facility** command on multirate 2/0/1 of the remote Cisco ONS 15530. If errors are seen at client B the optical connectors between client B and the remote Cisco ONS 15530 are dirty or need to be replaced.

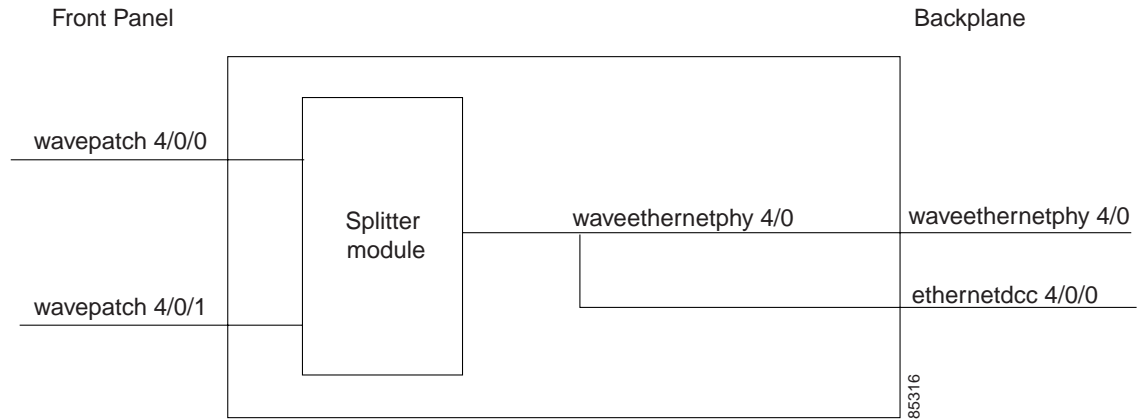
Figure 8-1 Splitter 2.5-Gbps ITU Trunk Card Interfaces

Figure 8-1 and Figure 8-2 show the interface models for the two versions of the 2.5-Gbps ITU trunk card, splitter and nonsplitter.

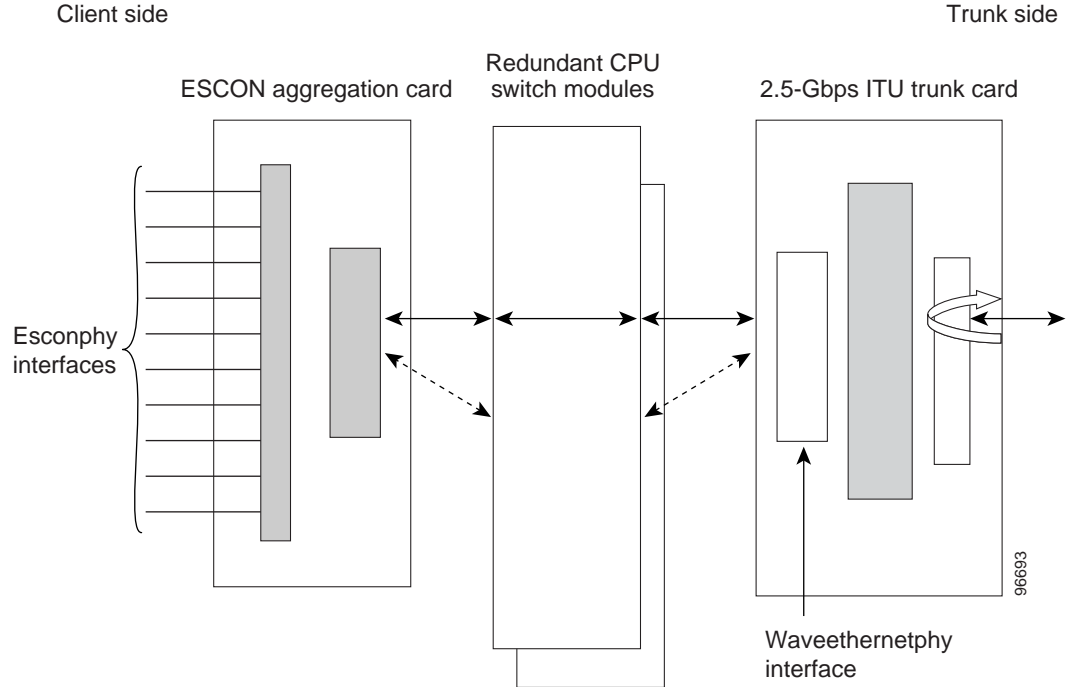
Figure 8-3 Facility Loopback Example on a 2.5-Gbps ITU Trunk Card

A facility loopback verifies the functioning of the 2.5-Gbps ITU trunk card from the trunk side (see Figure 8-3).

-
- Step 1** Issue a **loopback facility** command on the waveethernetphy interface.
 - Step 2** Check that the signal reaches the system at the far end.
 - Step 3** If the signal does not reach the far end, check the trunk fiber and the interfaces along the signal path. If the fiber is intact, replace the card.
-

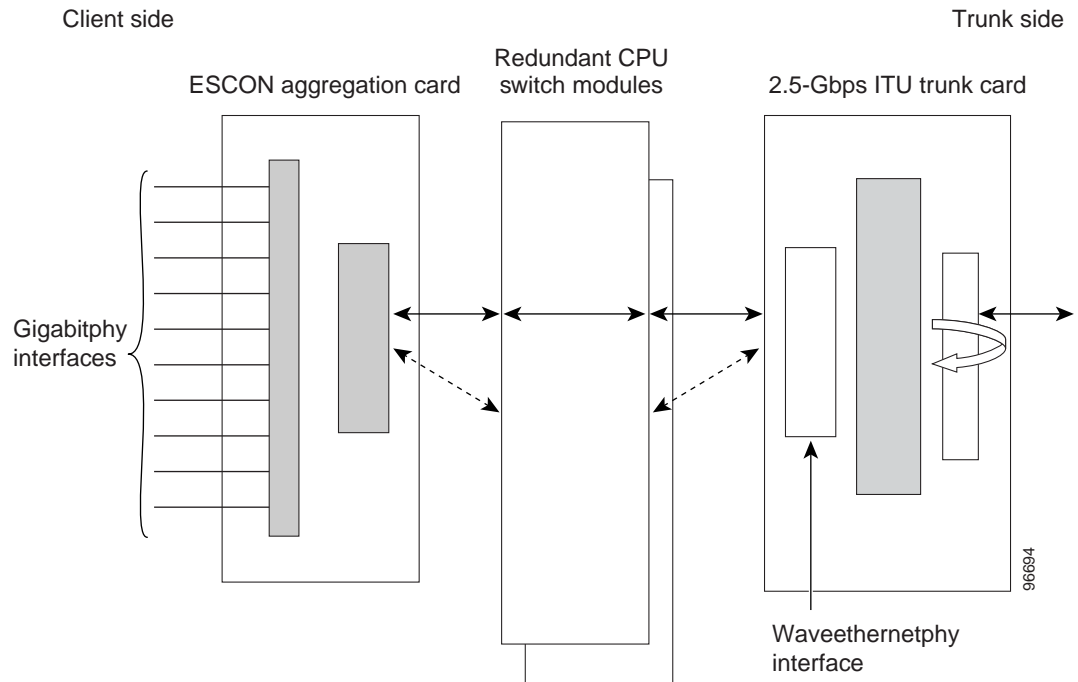
Figure 8-4 Terminal Loopback Example on a 2.5-Gbps ITU Trunk Card

A terminal loopback verifies the functioning of the 2.5-Gbps ITU trunk card from the switch fabric side (see Figure 8-4).

-
- Step 1** Issue a **loopback terminal** command on the waveethernetphy interface.
 - Step 2** Check that the traffic is reaching the client equipment.
 - Step 3** If the signal does not reach the client equipment, replace the card.
-

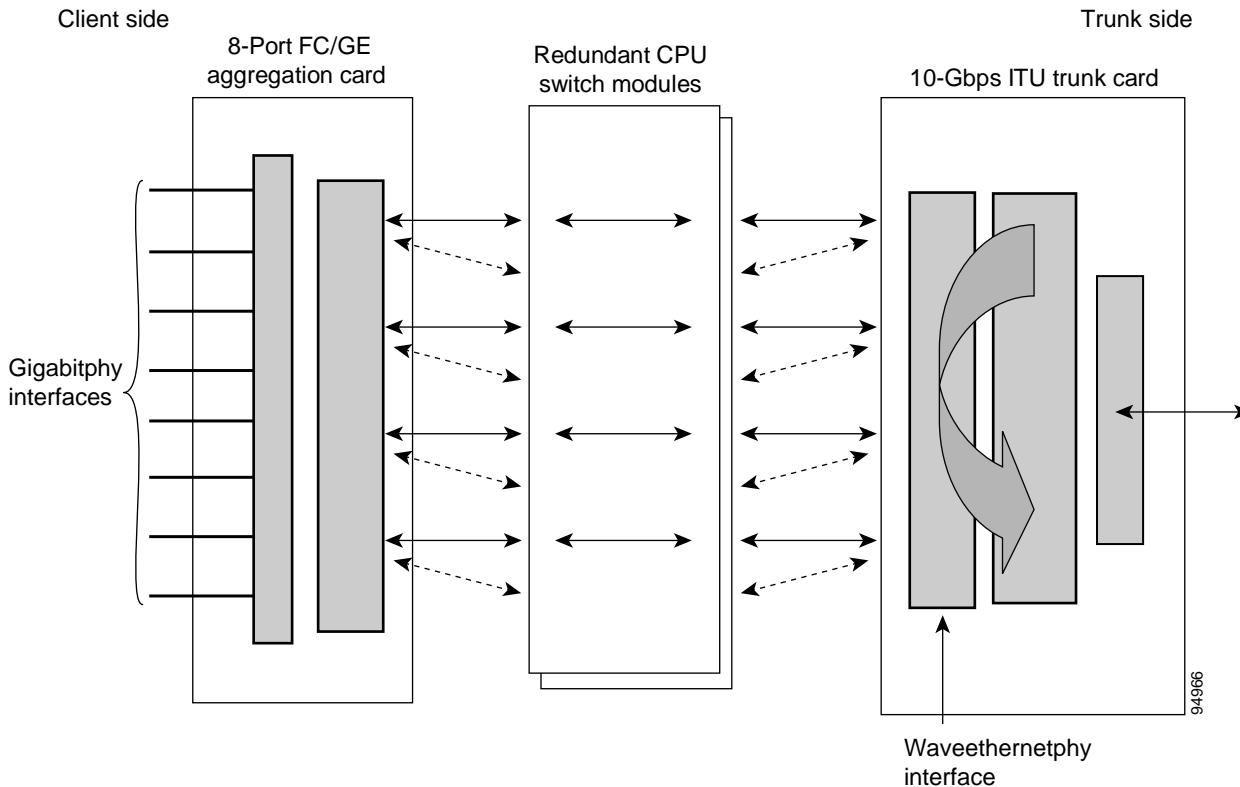
Figure 9-3 Facility Loopback Example on a 10-Gbps ITU Trunk Card

A facility loopback verifies the functioning of the 10-Gbps ITU trunk card from the trunk side (see Figure 9-3).

-
- Step 1** Issue a **loopback facility** command on the waveethernetphy interface.
 - Step 2** Check that the signal reaches the system at the far end.
 - Step 3** If the signal does not reach the far end, check the trunk fiber and the interfaces along the signal path. If the fiber is intact, replace the card.
-

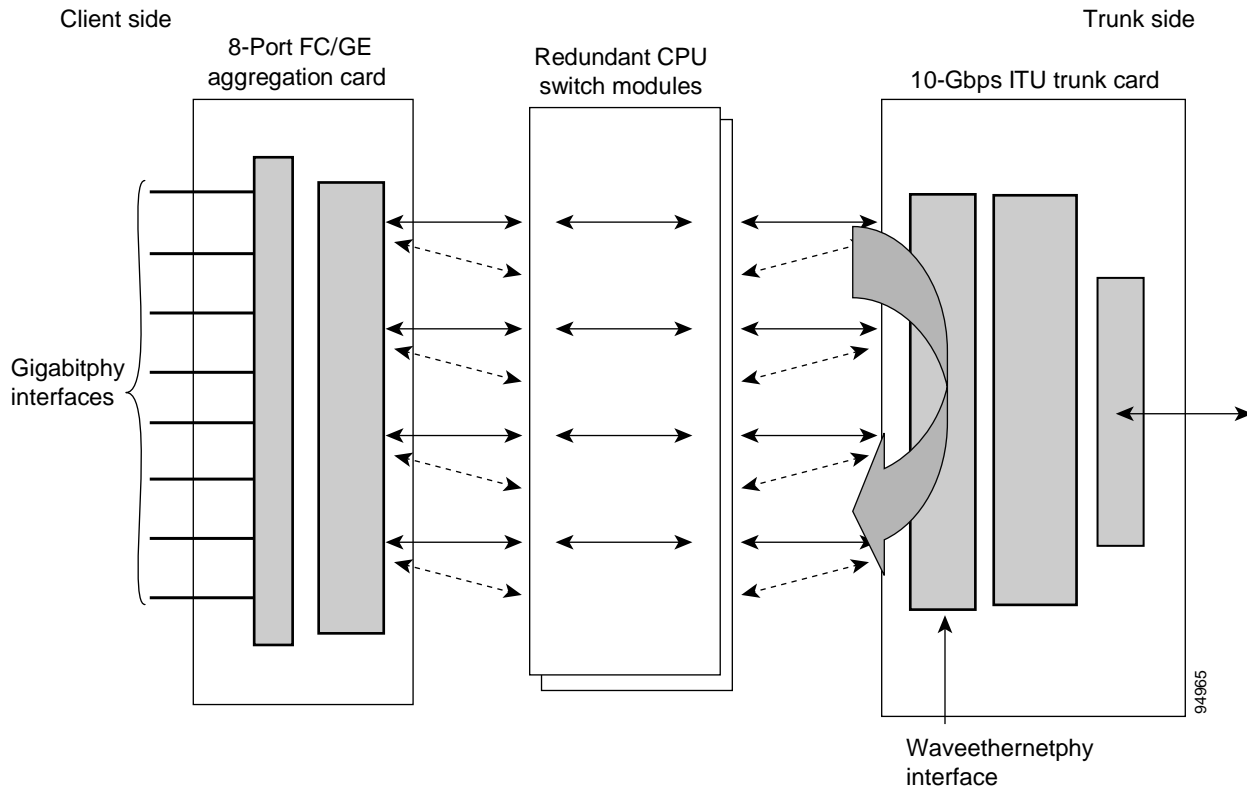
Figure 9-4 Terminal Loopback Example on a 10-Gbps ITU Trunk Card

A terminal loopback verifies the functioning of the 10-Gbps ITU trunk card from the switch fabric side (see Figure 9-4).

-
- Step 1** Issue a **loopback terminal** command on the waveethernetphy interface.
 - Step 2** Check that the traffic is reaching the client equipment.
 - Step 3** If the signal does not reach the client equipment, replace the card.
-

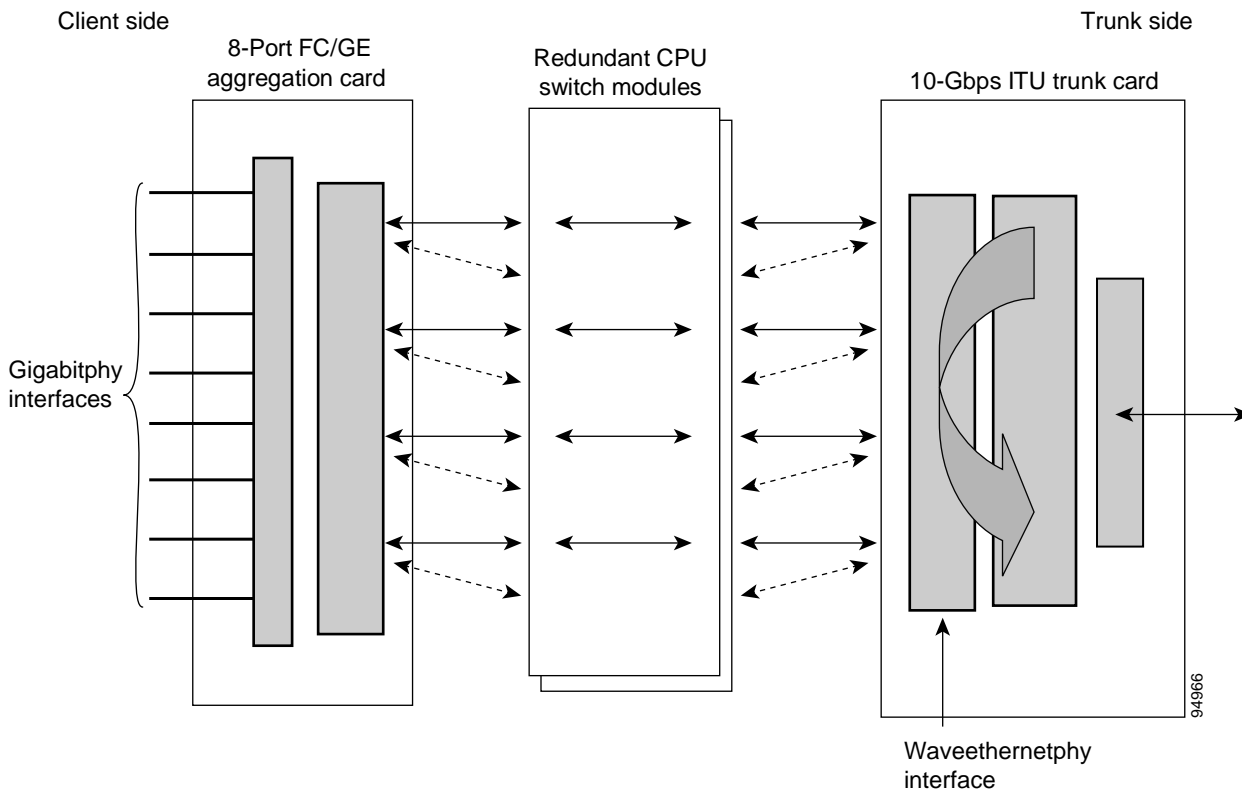
Figure 10-3 Facility Loopback Example on a 10-Gbps ITU Tunable Trunk Card

A facility loopback verifies the functioning of the 10-Gbps ITU tunable trunk card from the trunk side (see Figure 10-3).

-
- Step 1** Issue a **loopback facility** command on the waveethernetphy interface.
 - Step 2** Check that the signal reaches the system at the far end.

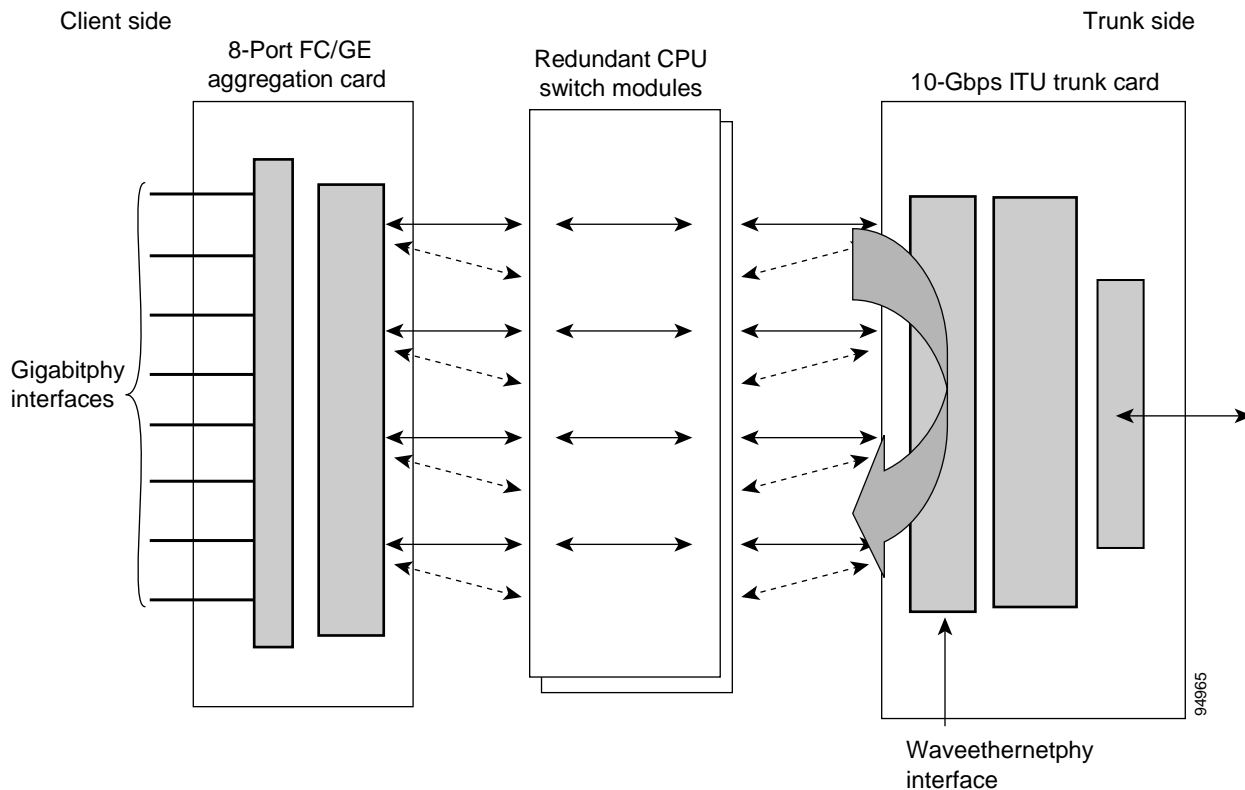
Figure 10-4 Terminal Loopback Example on a 10-Gbps ITU Tunable Trunk Card

A terminal loopback verifies the functioning of the 10-Gbps ITU tunable trunk card from the switch fabric side (see Figure 10-4).

- Step 1** Issue a **loopback terminal** command on the waveethernetphy interface.
- Step 2** Check that the traffic is reaching the client equipment.
- Step 3** If the signal does not reach the client equipment, replace the card.

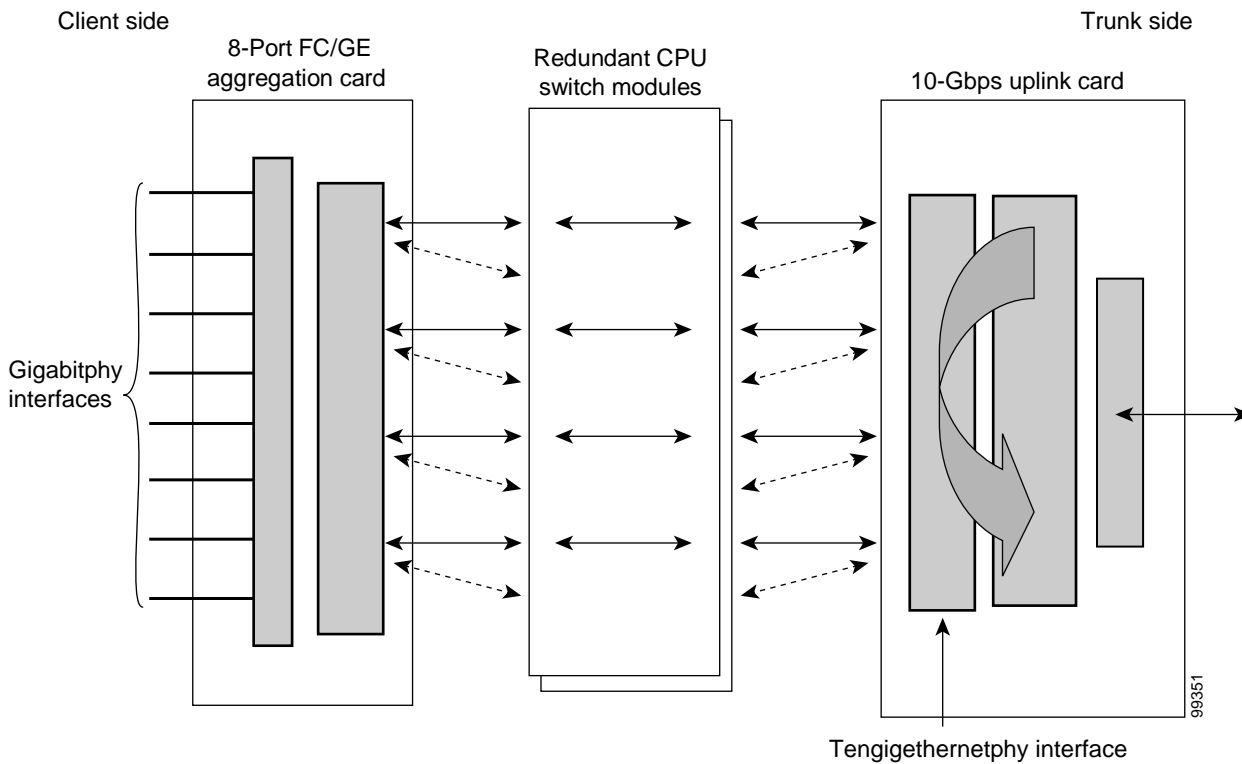
Figure 11-2 Facility Loopback Example on a 10-Gbps Uplink Card

A facility loopback verifies the functioning of the 10-Gbps uplink card from the trunk side (see Figure 11-2).

-
- Step 1** Issue a **loopback facility** command on the tenGigetherethy interface.
 - Step 2** Check that the signal reaches the system at the far end.
 - Step 3** If the signal does not reach the far end, check the trunk fiber and the interfaces along the signal path. If the fiber is intact, replace the card.
-

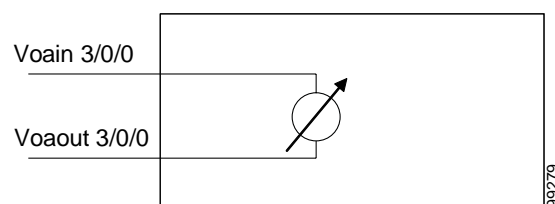
Figure 14-1 *Single WB-VOA Module Interfaces*

Figure 14-1 shows an example of the interfaces for a single WB-VOA module.

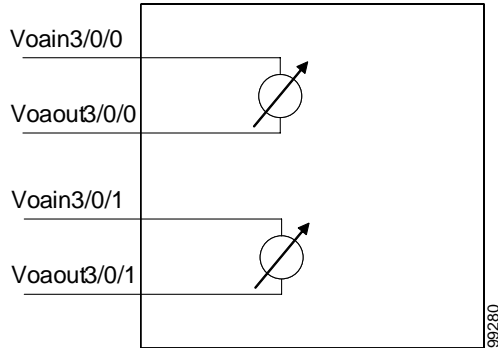
Figure 14-2 *Dual WB-VOA Module Interfaces*

Figure 14-2 shows an example of the interfaces for a dual WB-VOA module.

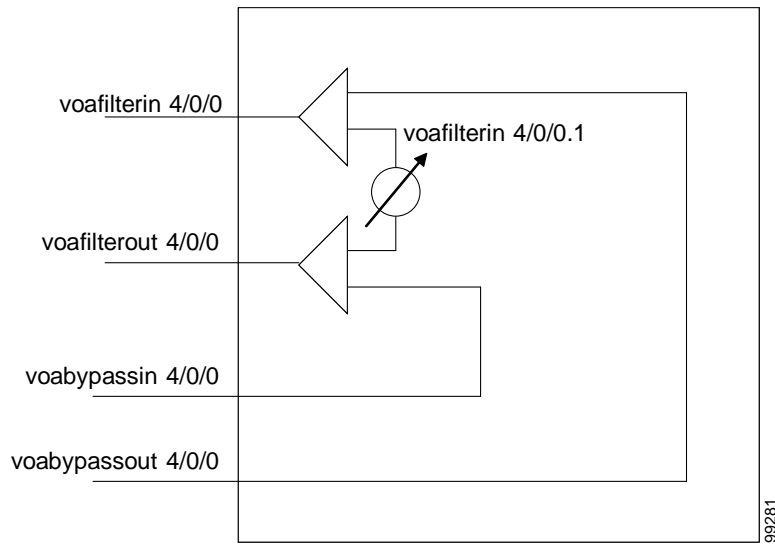
Figure 14-3 *Single PB-OE Module Interfaces*

Figure 14-3 shows an example of the interfaces for a single PB-OE module.
