Cisco ONS 15540 ESPx System Alarms and Error Messages

This document lists and describes system alarms and error messages for the Cisco ONS 15540 ESPx. The system software sends these alarms and error messages to the console (and, optionally, to a logging server on another system) during operation. Not all error messages indicate problems with your system. Some are purely informational, while others might help diagnose problems with links, internal hardware, or the system software.

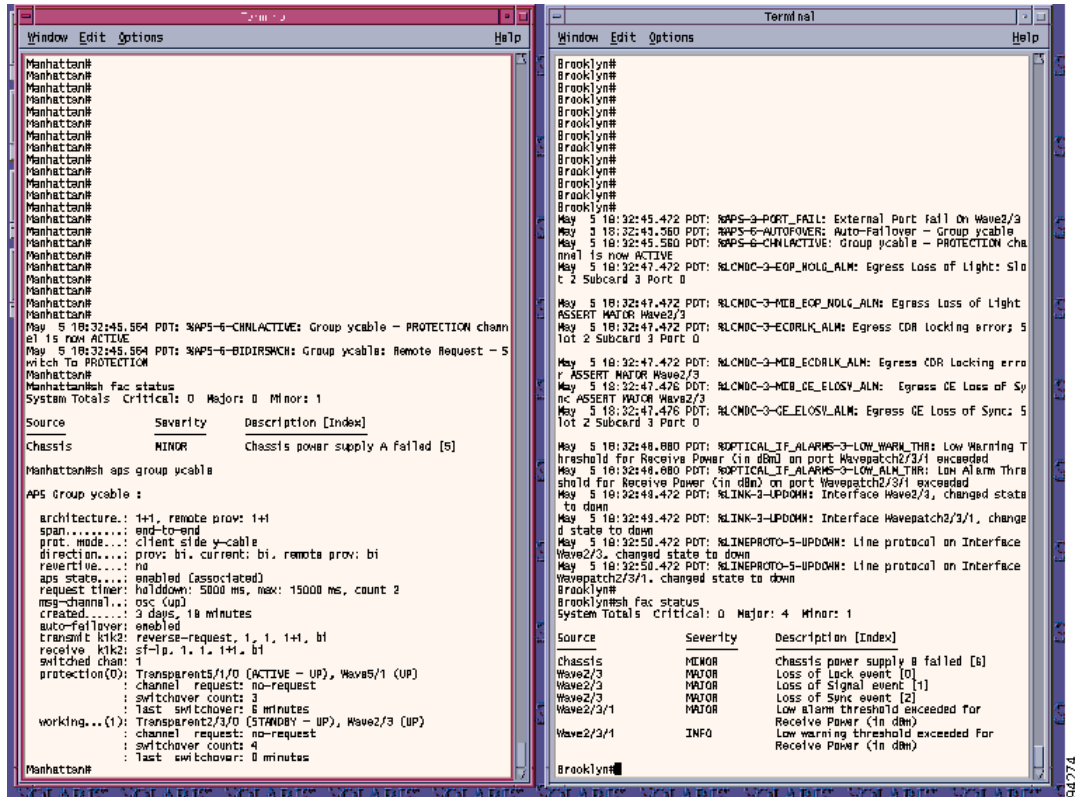
Figure 7 Status After Loss of Signal on the Wave Interface

Figure 7 and Figure 8 show the messages displayed after the failure. Note that there is Egress loss of light on wave interface 2/3 that in turn triggers the APS to switch over to standby transparent interface 5/1/0.
