Summa Four

**Generic V3.3 FSR06
Release Notes**

61040300633-OCR

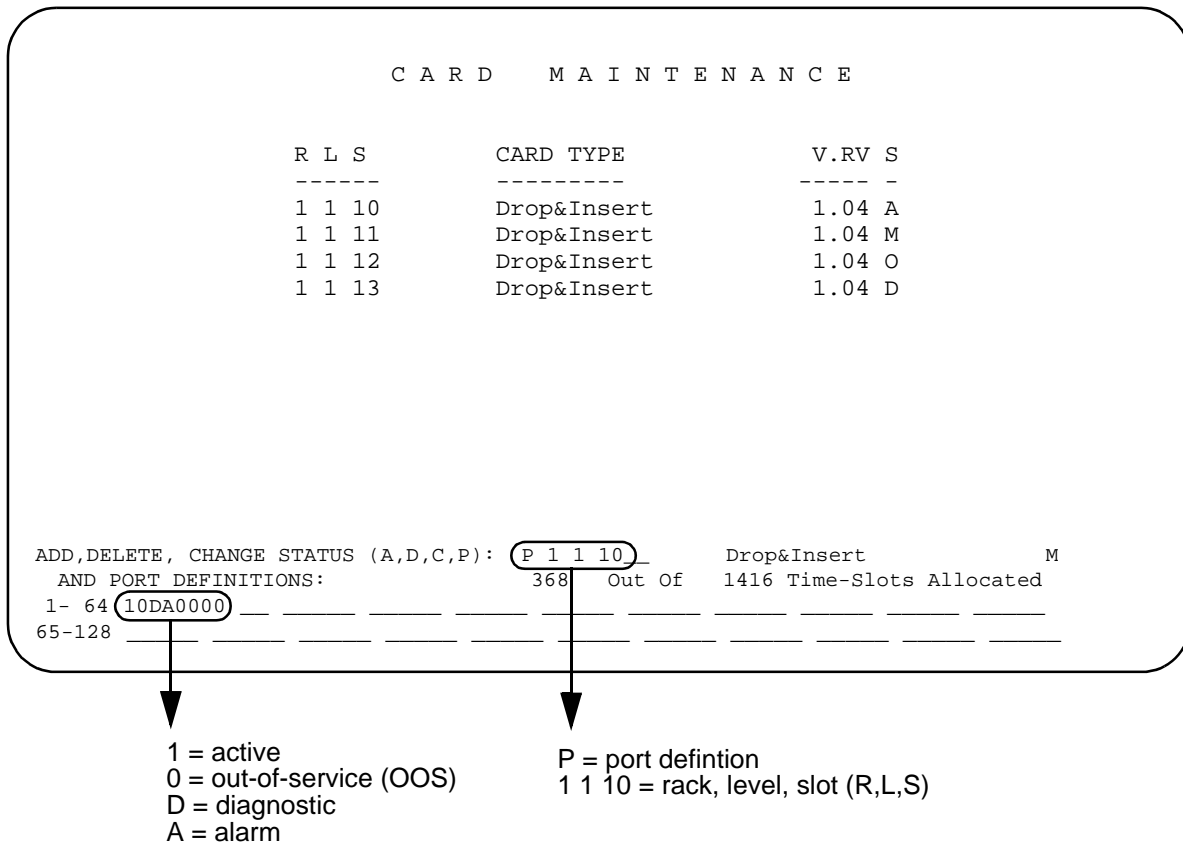
Figure 1.2: Card Maintenance Screen

In Figure 1.2, the ports on the D&I card in (R,L,S) 1-1-10 are in the following modes:

- Port 1—active mode
- Port 2—out of service
- Port 3—diagnostic mode
- Port 4—alarm state
- Ports 5 through 8—out of service

Administrators can activate or deactivate individual ports, or place them in diagnostic mode. To do this, type **P**, for Port Definition, in the Card Maintenance screen's command field, then indicate the location of the card (R,L,S). When the card ports are displayed, one of the following port states can be designated: ACTIVE (**1**), OOS (**0**), or DIAG (**D**). Refer to *Table 1.3* for a definition of the port states and Figure 1.2 for a sample Card Maintenance and port state screen display.

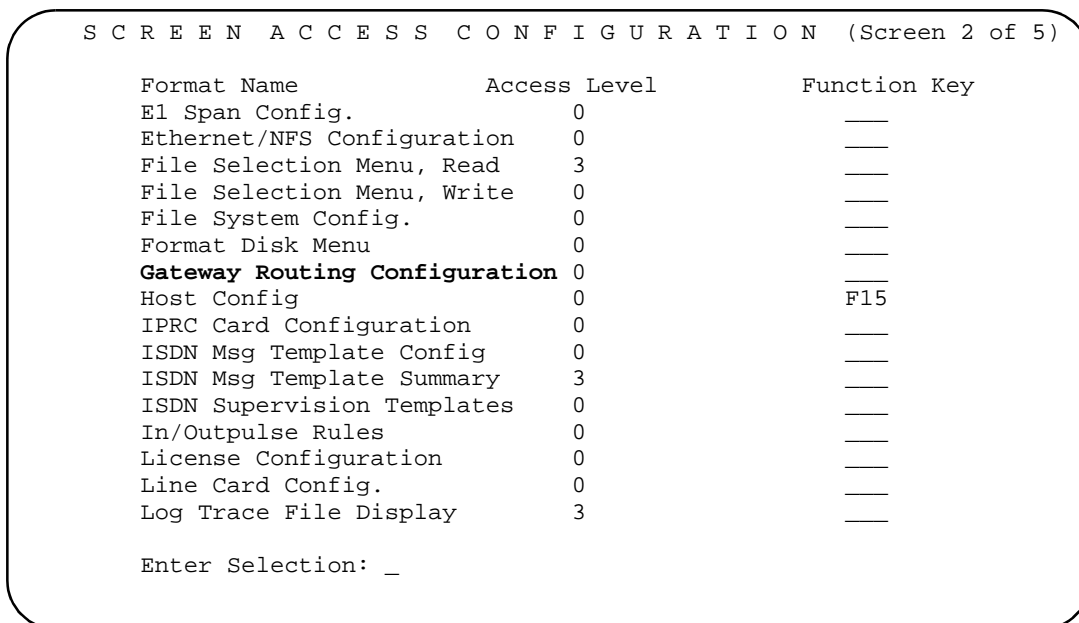
Gateway Routing configuration is under access control. When a user chooses Option G from the System Configuration Menu to bring up the Screen Access Configuration screen, a new line for Gateway Routing Configuration appears on the second of five screens. Valid access level entries are from 0 to 3. The default is 0 (full access). Refer to Figure 1.13.

```
SCREEN ACCESS CONFIGURATION (Screen 2 of 5)

Format Name           Access Level      Function Key
E1 Span Config.       0                ___
Ethernet/NFS Configuration  0                ___
File Selection Menu, Read  3                ___
File Selection Menu, Write  0                ___
File System Config.    0                ___
Format Disk Menu      0                ___
Gateway Routing Configuration  0                ___
Host Config           0                F15
IPRC Card Configuration  0                ___
ISDN Msg Template Config  0                ___
ISDN Msg Template Summary  3                ___
ISDN Supervision Templates  0                ___
In/Outpulse Rules     0                ___
License Configuration  0                ___
Line Card Config.     0                ___
Log Trace File Display  3                ___

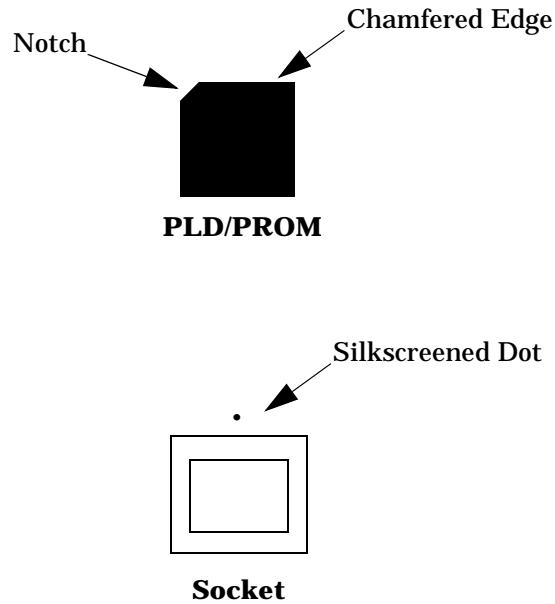
Figure A.5: PLD Alignment

1. Before installing the new PROM or PLD, verify that the pins are all evenly spaced and properly aligned. If necessary, use tweezers to carefully align the IC pins prior to installation.
2. Align the notch or chamfered edge on the PROM or PLD to the silkscreened dot on the circuit card (see Figure A.5).

3. With all pins aligned to the pins of the socket, apply gentle, even finger pressure to the top of the chip until it is fully seated in its socket. This completes the installation of the surface mount chip.
4. With all the pins inserted into the socket, apply gentle and even pressure to the top of the chip until it is fully seated in the socket.
5. Reinstall the circuit card in the system or return the card to spares stock.
