Summa Four

**Generic V4.0 FSR02 PUN 22
Release Notes**

61220300240-0DR

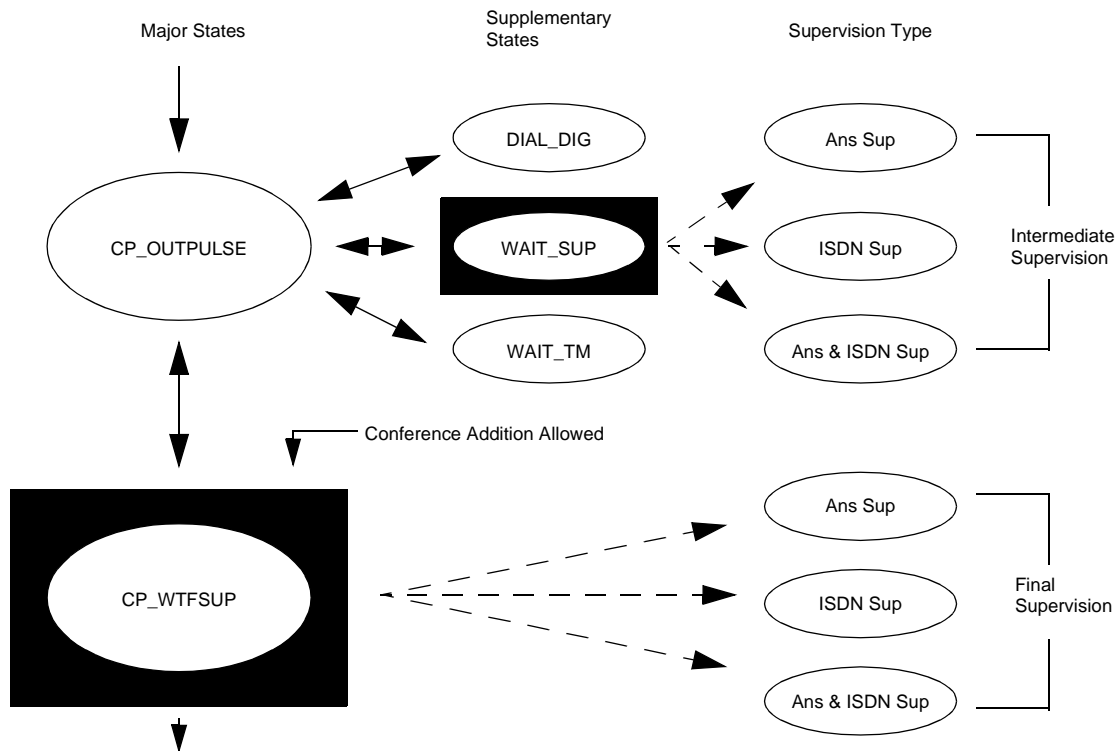
Figure 1.7: Adding an ISDN Port to a Conference Call

This enhanced version of the generic software supports the addition of an ISDN port to a conference immediately following a SETUP message. To enable this feature, support is now included that allows an ISDN port to enter the CP_WTFSUP state.

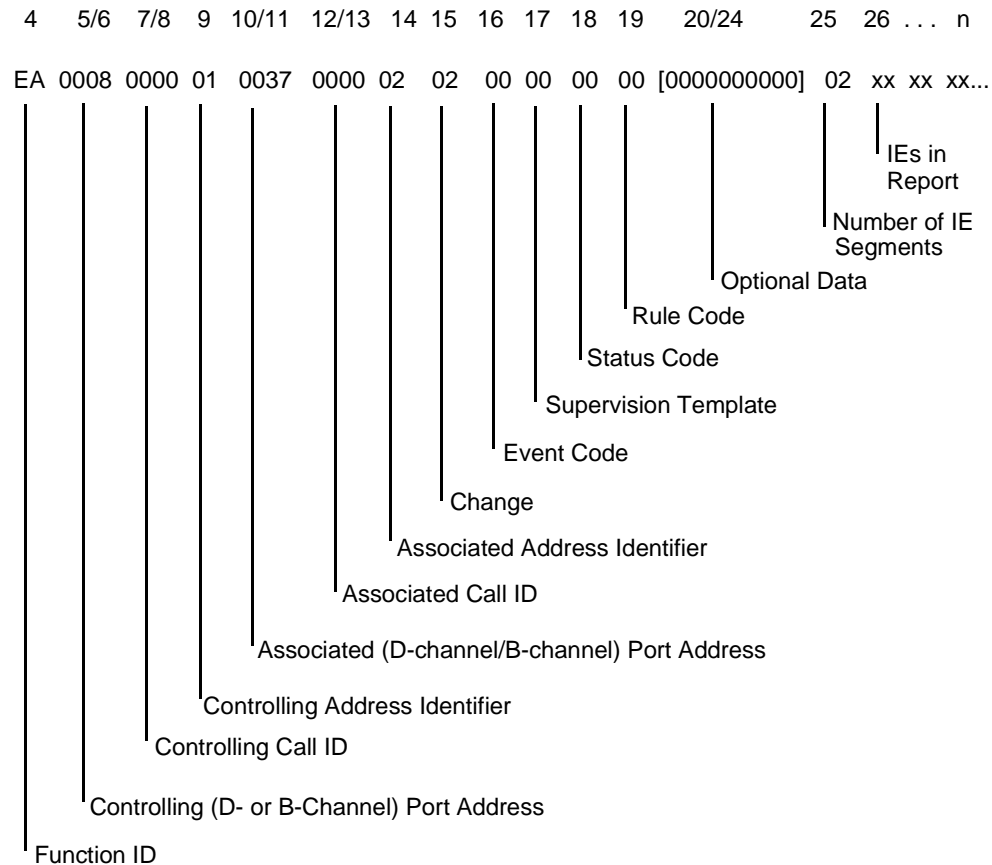
When a D-channel RESTART message is received, the standard ISDN Port Change of State (\$EA) report is generated in the format shown on the next page:

Controlling Port Addr (byte offset 5/6) – Hex representation of the controlling port circuit address for which the report is sent.

Controlling Call Id (byte offset 7/8) – Specifies the ISDN Call ID for the controlling port. Controlling Call ID is 00 00 for non-ISDN port address.

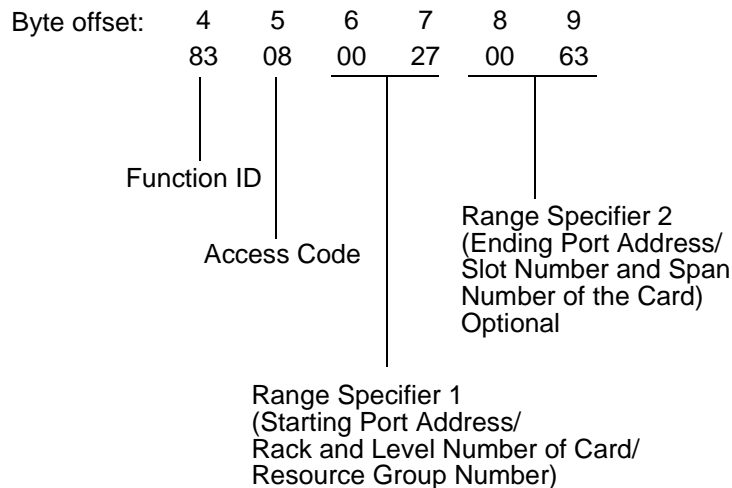
Function ID (byte offset 4) – Byte immediately following the network header; uniquely identifies the report from the SDS system.

Access Code (byte offset 5) – A port address range can be specified in different ways. The access code specifies the way in which the port address range is chosen. Construct byte in binary according to the descriptions below, then convert to hex for use in the command.
