**Generic V5.0 FSR 00
Release Notes**

61220300050-08P

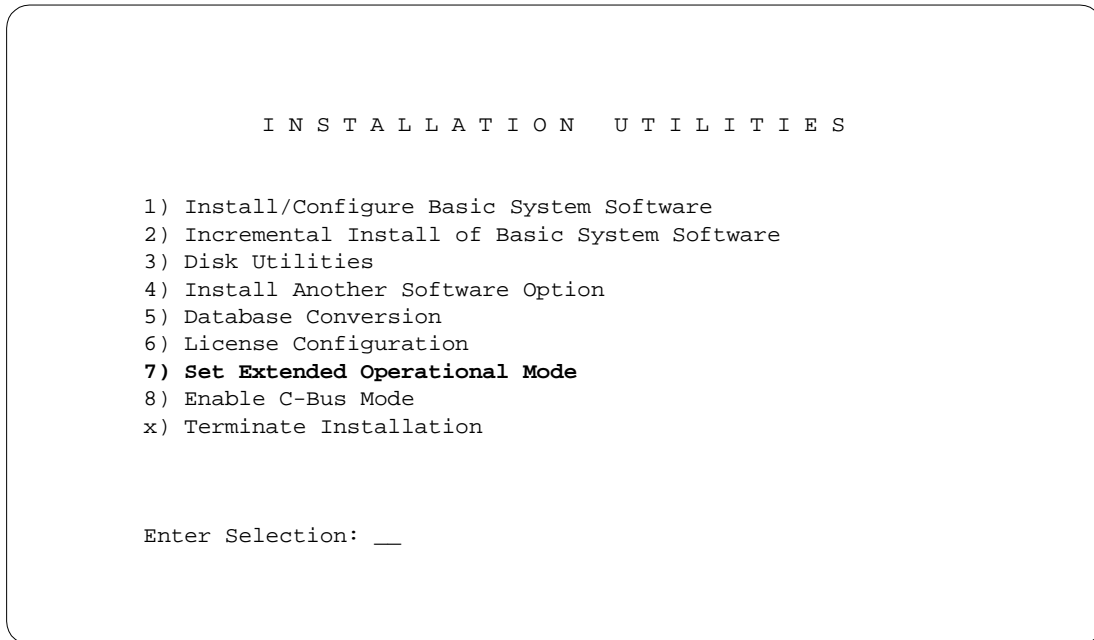
Figure 2.1: Installation Utilities Screen

Extended Operational Mode requires an addition to the Installation Utilities screen as shown in *Figure 2.1*. Select **7** for the new Set Extended Operational Mode option.

TP000005

To take advantage of the increased system limits, a menu option, Set Extended Operational Mode, has been added to the Installation Utilities screen. This screen, shown in *Figure 2.1*, appears during the installation process.

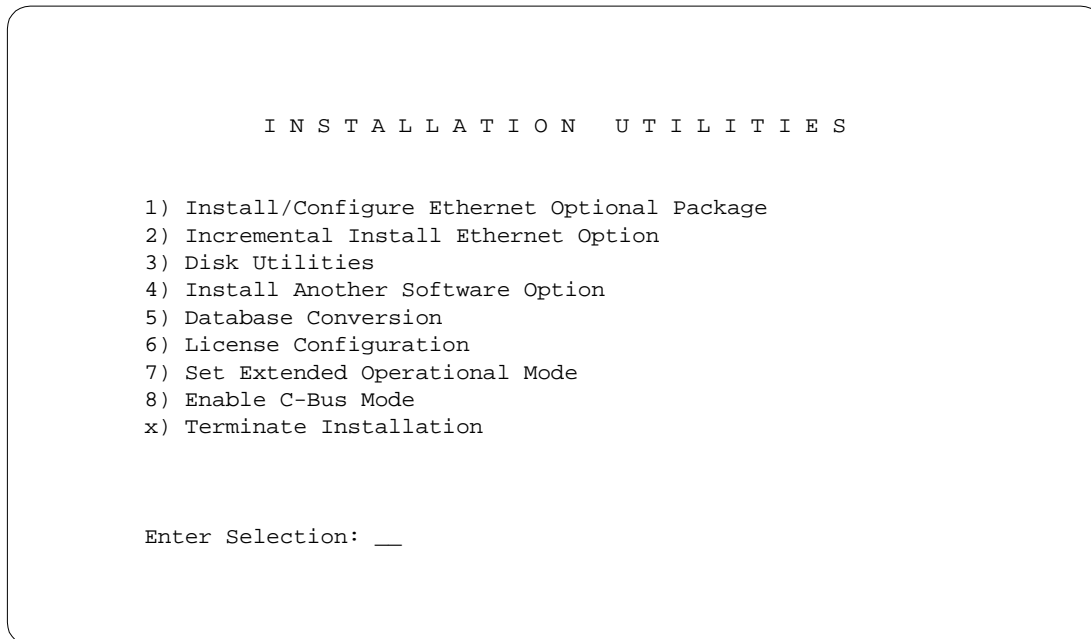
Figure 4.2: Ethernet Installation Utilities Menu

1. Insert the Ethernet software diskette and press the **Return** key. After the system loads the Ethernet files from the diskette, the Ethernet Installation Utilities menu appears with the cursor located in the Enter Selection field (see *Figure 4.2*).

TP000070

Type **6** to exit and press **Return**. The Installation Utilities screen appears (see *Figure 4.2*).
