**Generic Software
Release Notes
V5.1 FSR00 PUN00**

61220300051-02P

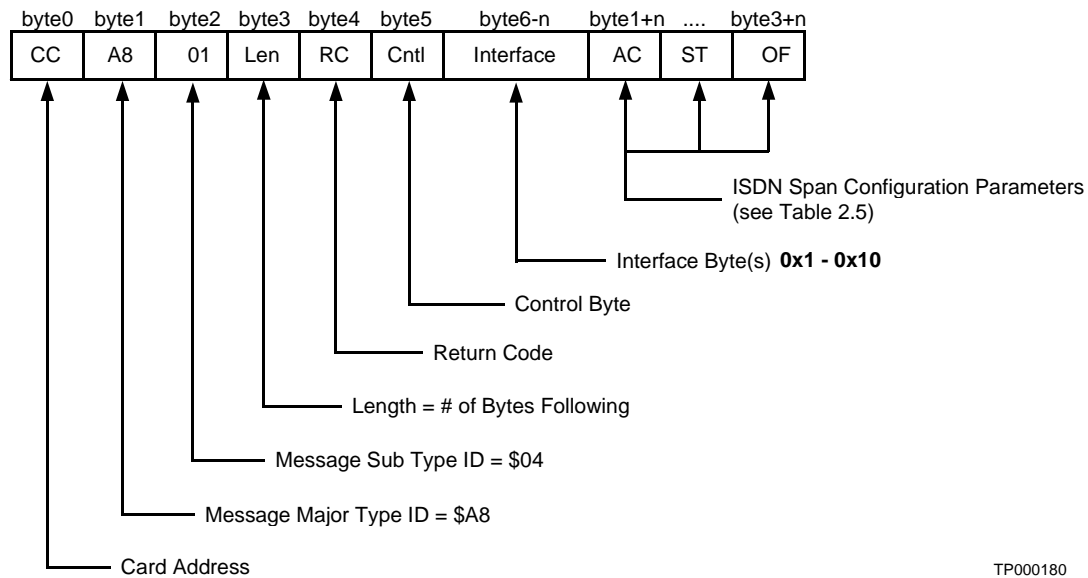
The \$A8/04 message is applicable only to the ISDN ICC. See *Figure 2.8* for the \$A8/04 message format.

Figure 2.8: \$A8/04 Message Format

A new ISDN span configuration command, \$A8/04, has been added. This message configures ISDN stack specific span parameters for one or more spans on the ICC. If multiple spans are configured identically, the spans are identified in the Interface Byte, see *Figure 2.8*. This message is derived from the \$13 command, and follows the \$A8/01 command for configuring an ISDN span.

Table 2.5 displays the ISDN span configuration parameters for byte1+n, ..., and byte3+n of the \$A8/04 command, as shown in *Figure 2.8*.

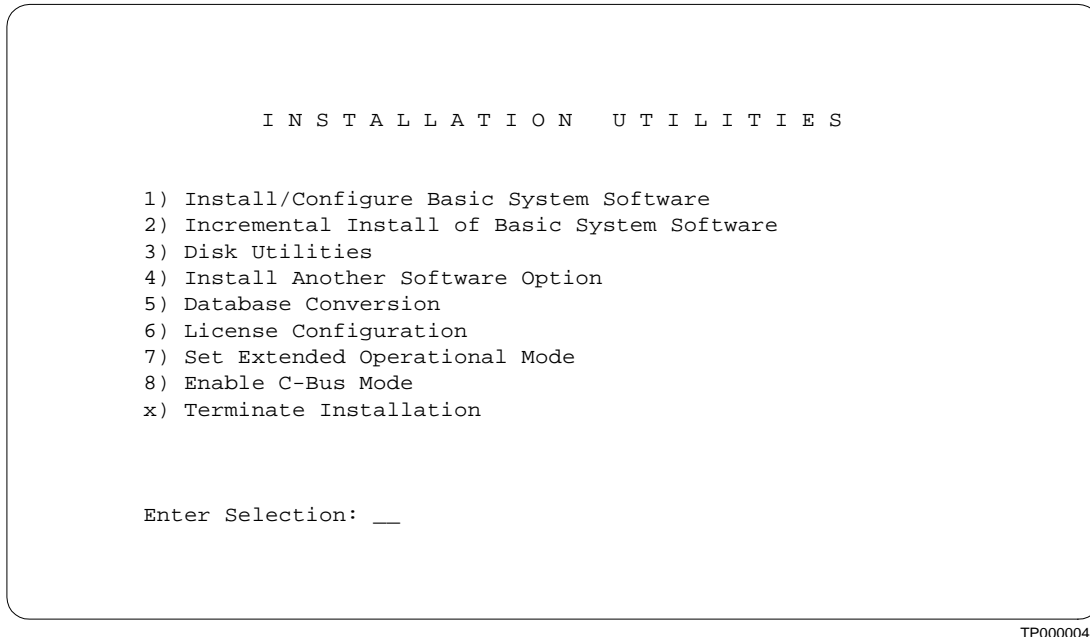
Figure 4.1: Installation Utilities Menu

When the installation is complete, the Installation Utilities menu appears again (Figure 4.1).

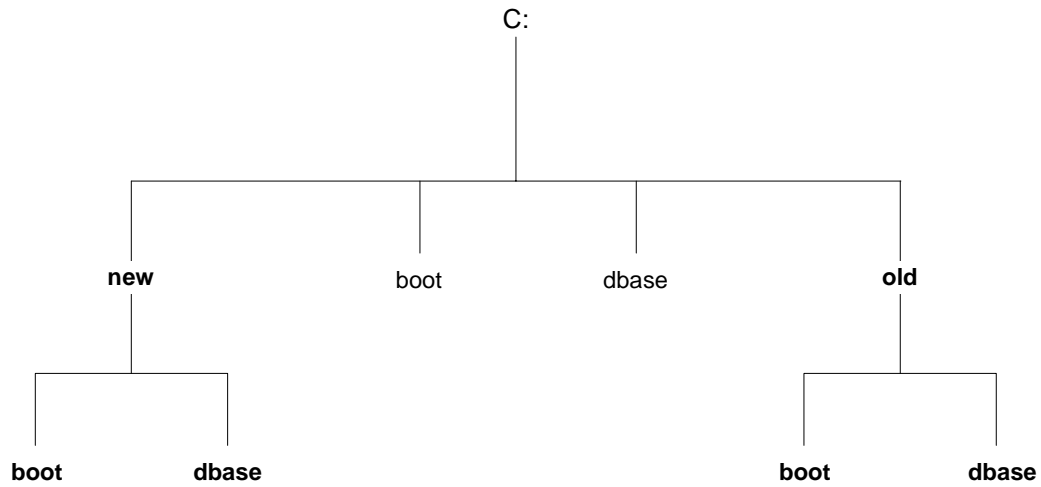
TP000114

The directory structure that is required by the upgrade process is shown in *Figure 5.2*. The directories created for the upgrade procedure are shown in bold; they are automatically created by the generic software when you select the Prepare for Install option. If they already exist, any existing files are removed from the directories. The directories themselves are maintained, and are used during the upgrade process.

Figure 5.2: Upgrade Process Directory Structure

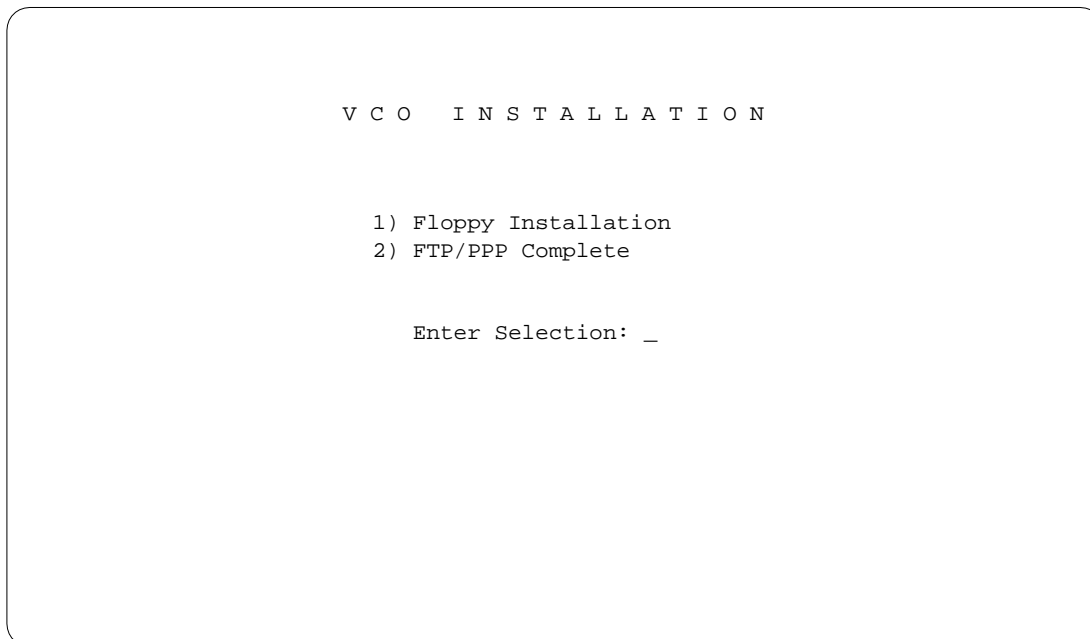
TP000115

When you select the Install New Release option from the Live Upgrade Control Menu, the VCO Installation screen is displayed as shown in *Figure 5.3*.

Figure 5.3: VCO Installation Screen

When the FTP transfer of the new generic software to the hard disk is complete, you must indicate that the transfer is complete by selecting Option 2 in the VCO Installation screen; refer to *Figure 5.3* on page 8. The generic software then verifies that the transfer is complete. Successful transfer is indicated by the Check for all Files Successful message.

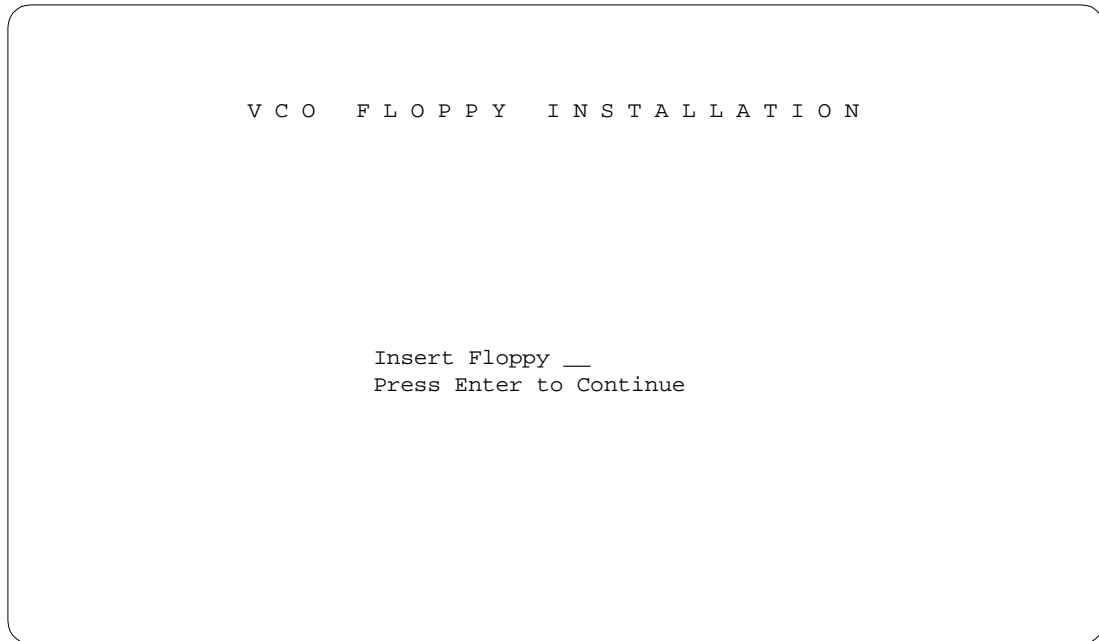
TP000116

To install from floppy diskettes, type **1**, then press **Enter**. The VCO Floppy Installation screen is displayed, as shown in *Figure 5.4*.

Figure 5.4: VCO Floppy Installation Screen

The floppy diskette number is displayed in the VCO Floppy Installation screen; for example, Insert Generic Floppy 1. When you insert the floppy diskette the volume label is verified. Your response (for example, if you pressed the **Enter** key to continue) is logged in the upgrade log file along with the files that are being installed. If any files are missing from the floppy, or if there is a mismatch, the upgrade is aborted.

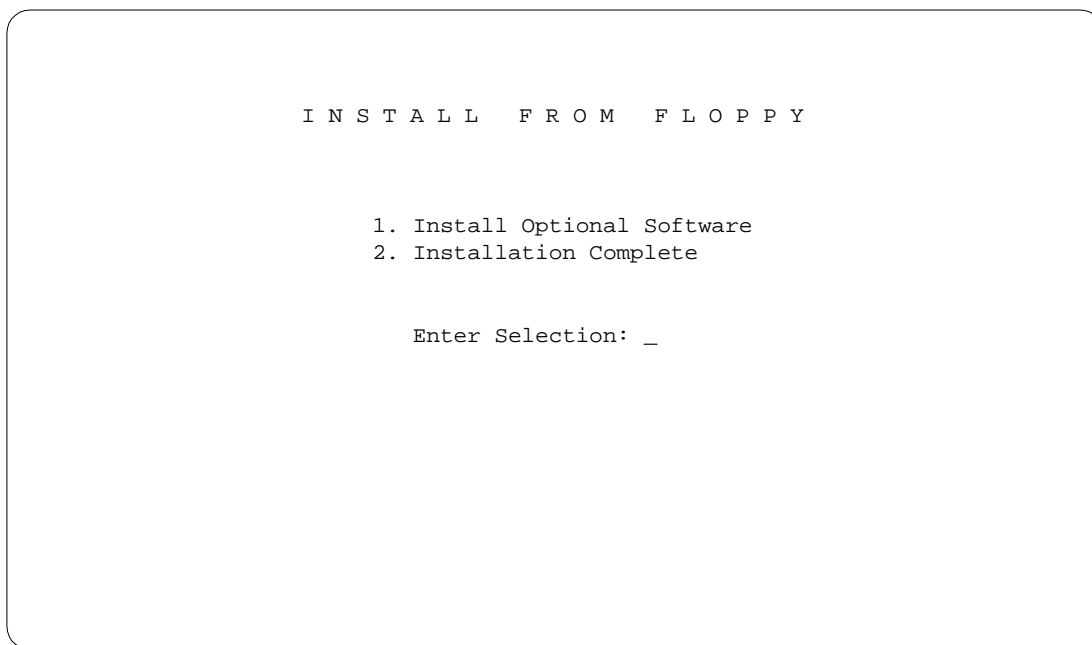
TP000117

After completing the installation of an option, the menu in *Figure 5.5* appears again. Select Option 1 again to install another software package, or select Option 2: Installation Complete, to terminate the installation.

Figure 5.5: Install from Floppy Screen

After all software diskettes have been installed, you are prompted to install optional software as shown in *Figure 5.5*. If no other software is to be installed, select option **2: Installation Complete**, shown in *Figure 5.5*, and press **Enter** to exit the installation.

After the generic software is installed, you can install optional software package files; refer to *Figure 5.5*.

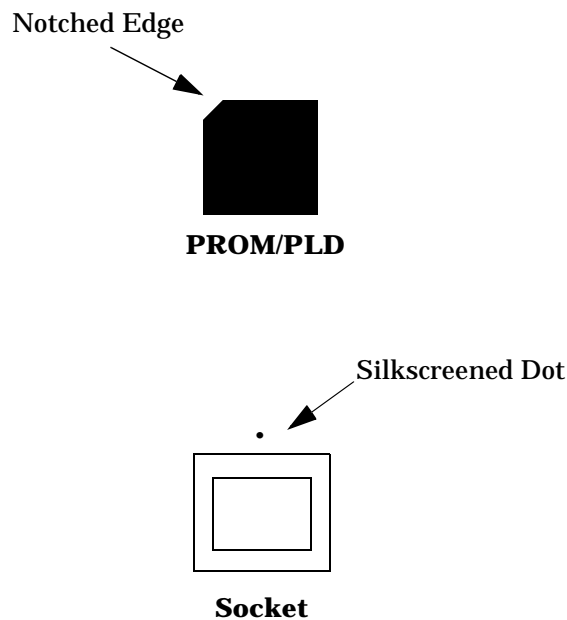
1. Before installing the new PROM or PLD, verify that the pins are all evenly spaced and properly aligned. If necessary, use tweezers to carefully align the IC pins prior to installation.
2. Align the notched edge on the PROM/PLD to the silkscreened dot on the circuit card, as shown in *Figure A.4*.

Figure A.4: PROM/PLD Alignment

3. With all pins aligned to the pins of the socket, apply gentle, even finger pressure to the top of the chip until it is fully seated in its socket. This completes the installation of the surface mount chip.
4. Reinstall the circuit card in the system or return the card to spares stock.
