**SDS/VCO Generic
Release Notes Addendum
V4.2 FSR00 PUN 25**

63103950142-0AR

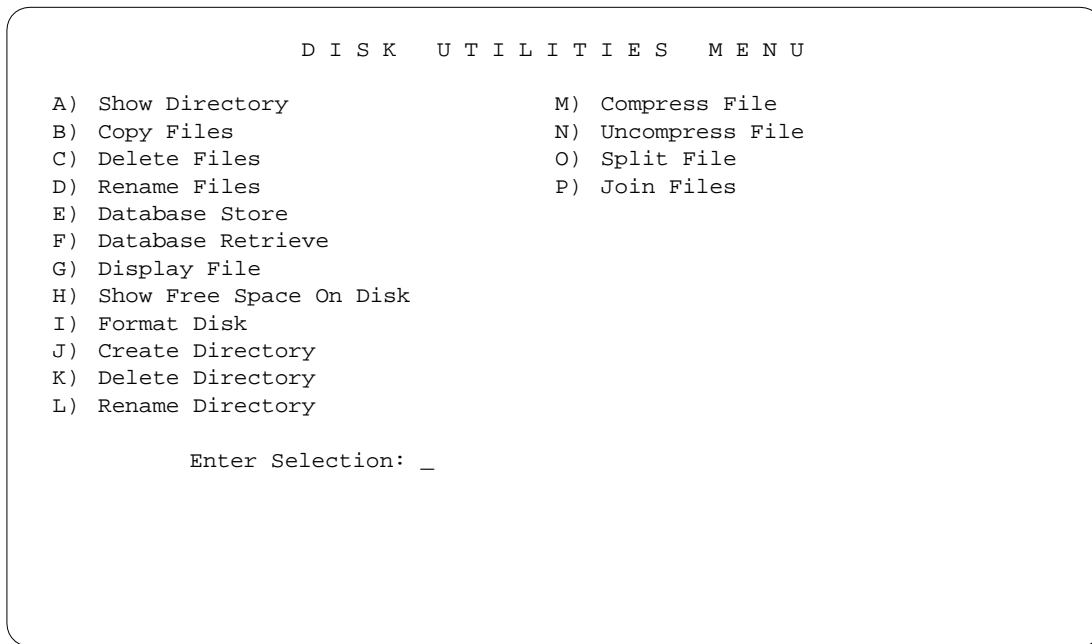
Figure 3.2: Disk Utilities Menu

2. Remove any diskette in the diskette drive on the A-side and insert a high-density diskette.
3. Type **B** to access the Disk Utilities, and press the **Return** key. The Disk Utilities menu appears (Refer to Figure 3.2.)

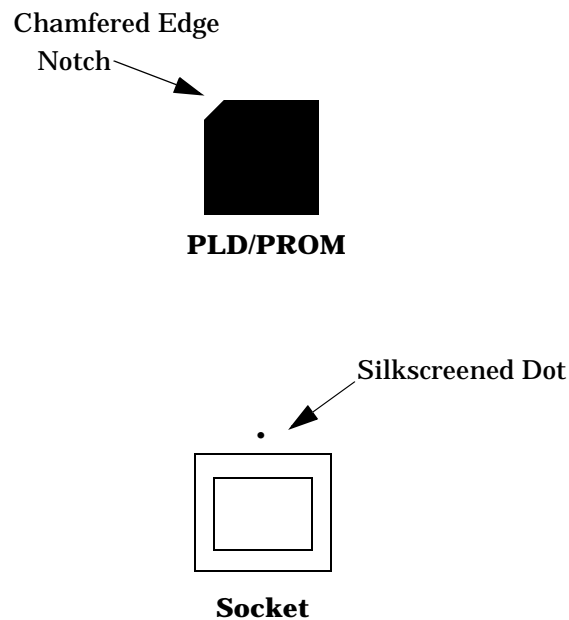
Figure 3.7: PLD Alignment

1. Before installing the new PLD, verify that the pins are all evenly spaced and properly aligned. If necessary, use tweezers to carefully align the IC pins prior to installation.
2. Align the notch or chamfered edge on the PLD to the silkscreened dot on the circuit card (see Figure 3.7).

3. With all pins aligned to the pins of the socket, apply gentle, even finger pressure to the top of the chip until it is fully seated in its socket. This completes the installation of the surface mount chip.
4. Reinstall the circuit card in the system or return the card to spares stock.

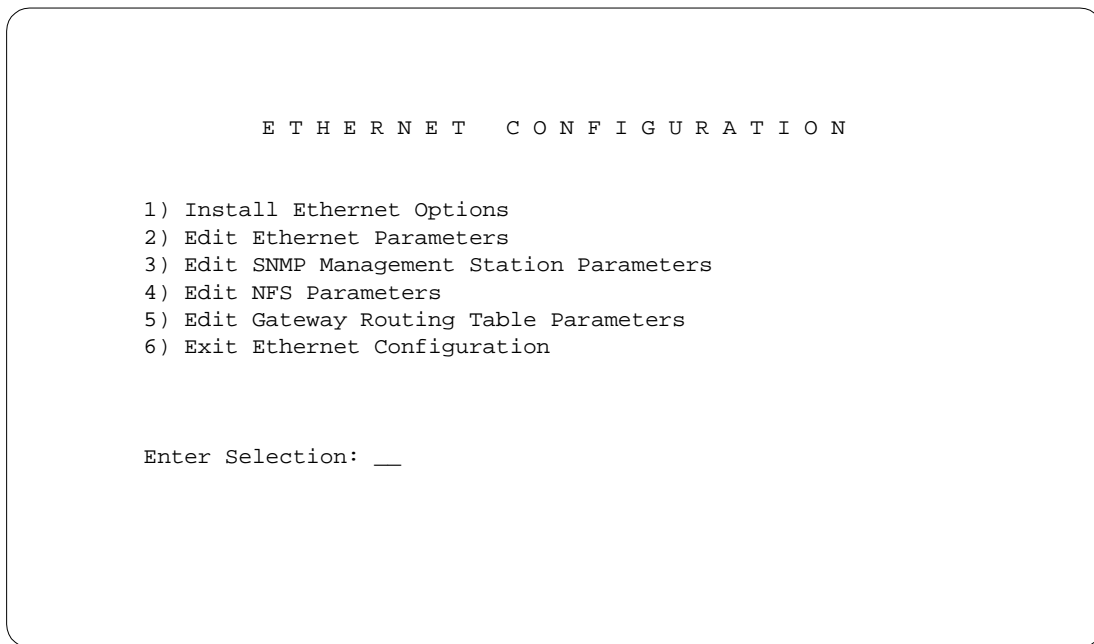
Figure 3.10: Ethernet Configuration Menu

The Ethernet Configuration menu appears (see *Figure 3.10*).
