**SDS/VCO Generic  
Release Notes  
V4.2 FSR00 PUN 24**

61220300042-OCR

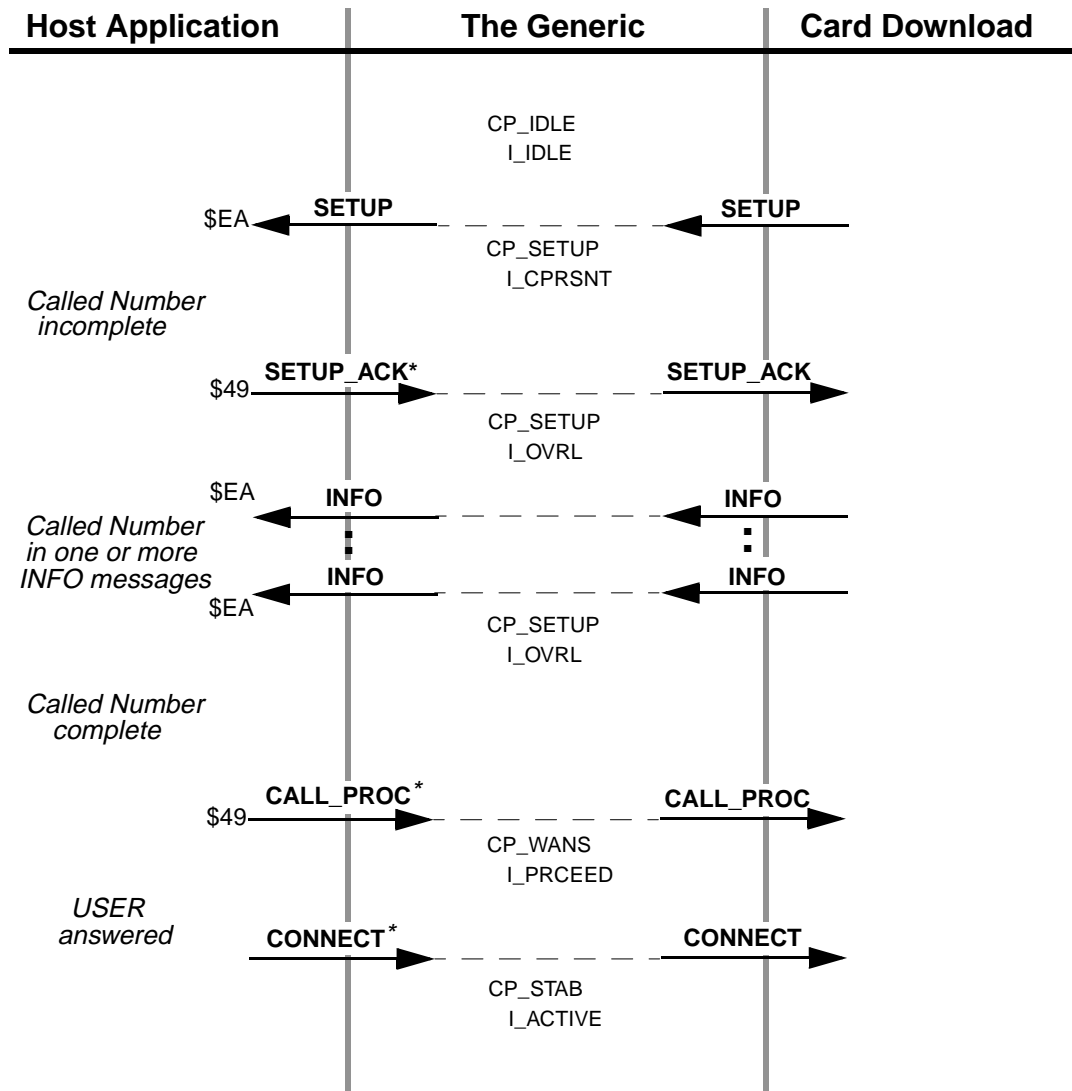
Figure 1.8: Overlap Receiving with Indication (SETUP\_ACK) from Host Application

\* Messages are initiated by the Host Application but actually sent from the Generic

Note that in *Figure 1.8*, the \$EA report, not the \$ED report, is sent to the Host Application for the SETUP message.

The Generic considers this as an indicator of the end of Overlap Receiving; I\_PROCEED state is entered. Refer to *Figure 1.8*.

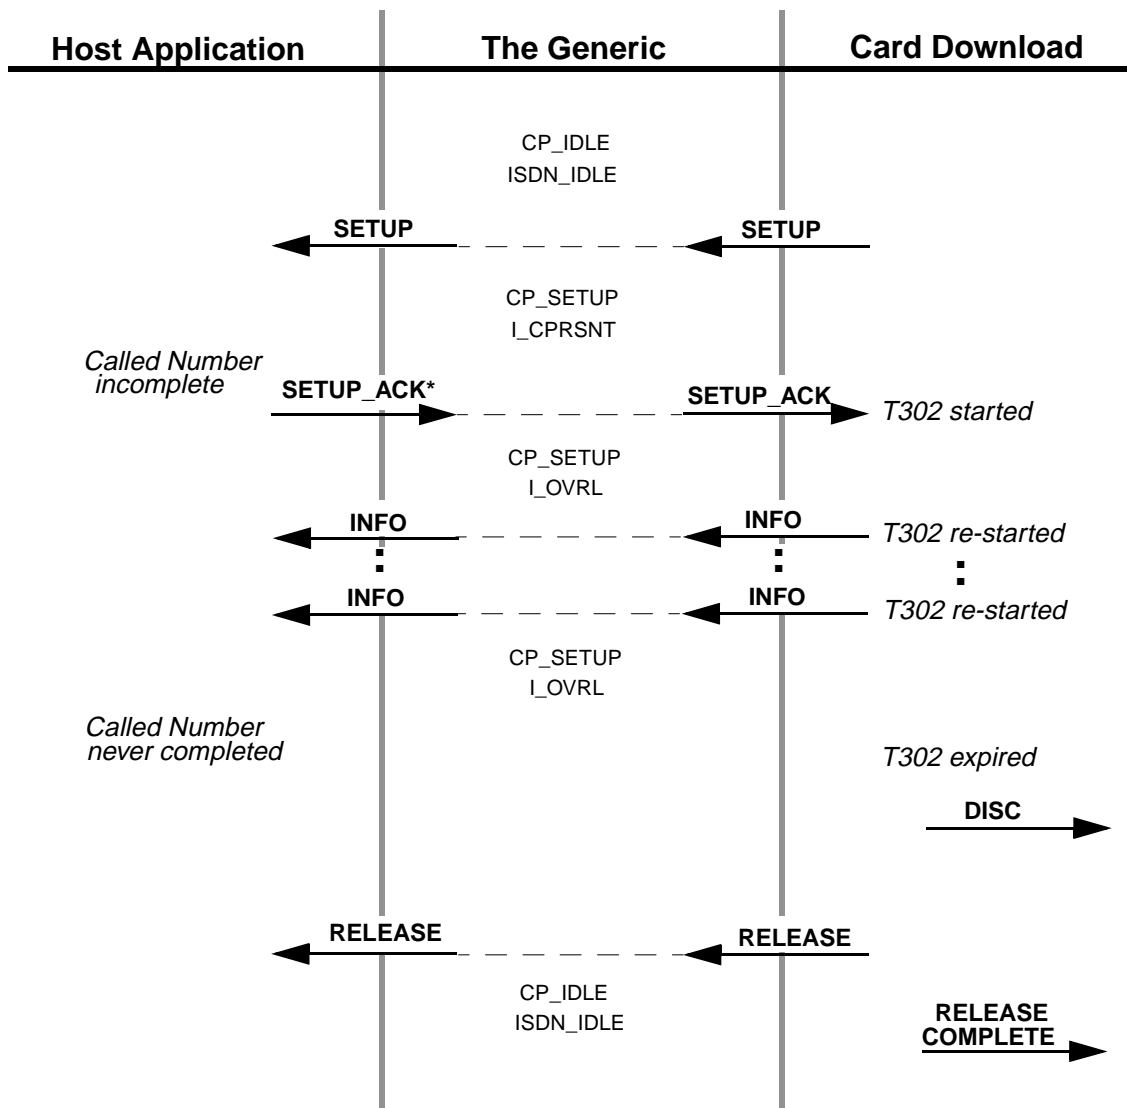
Figure 1.9: T302 Expiry and Call Clearing from the Card Download

*Figure 1.9* shows the T302 expiry and call clearing processing initiated by USER. The first call clearing message is RELEASE from NETWORK.

\* Messages are initiated by the Host Application but actually sent from the Generic

The system uses a timer (T302) when in Overlap Receiving to control call clearing (aborting). Refer to *Figure 1.9*. The timer resides in, and is controlled by, the card download.

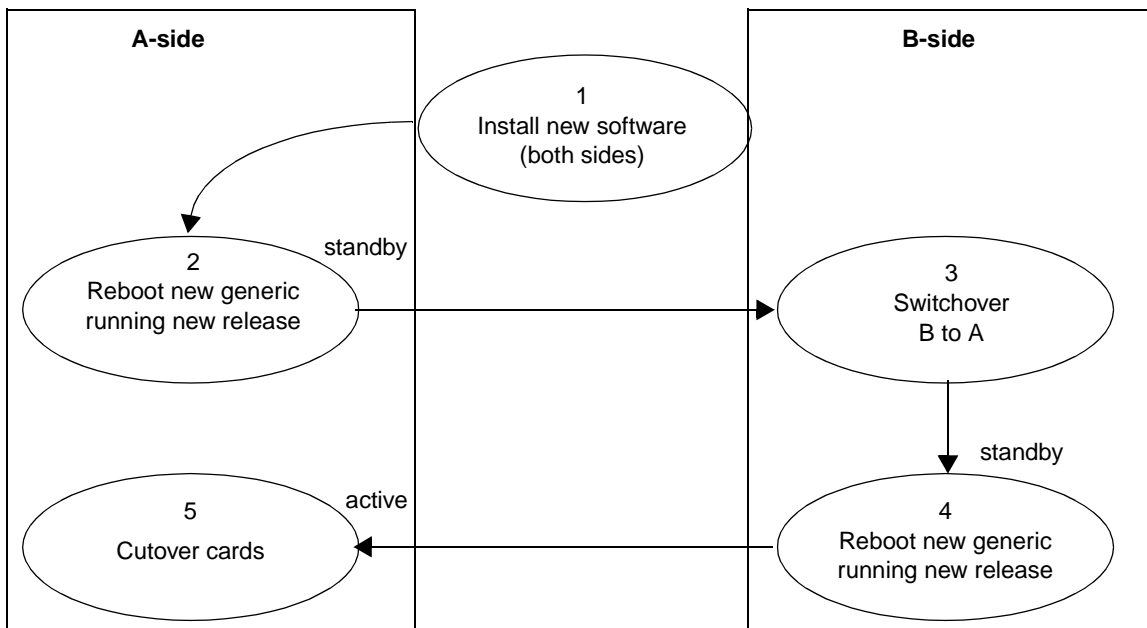
Figure 1.14: Overview of the Upgrade Process

The upgrade process is illustrated in *Figure 1.14*. Note in the illustration that the A-side is initially in standby mode. The A-side controller is upgraded with the new generic software and rebooted. After rebooting, a switchover is performed, making the A-side and the new software active. This procedure allows the system to maintain live traffic while being upgraded and switched to the new software.

*Note: If the B-side is in standby mode, the B-side would be upgraded and rebooted first.*
