**Generic Software
Release Notes
V5.0 FSR00 PUN25**

61220300050-10P

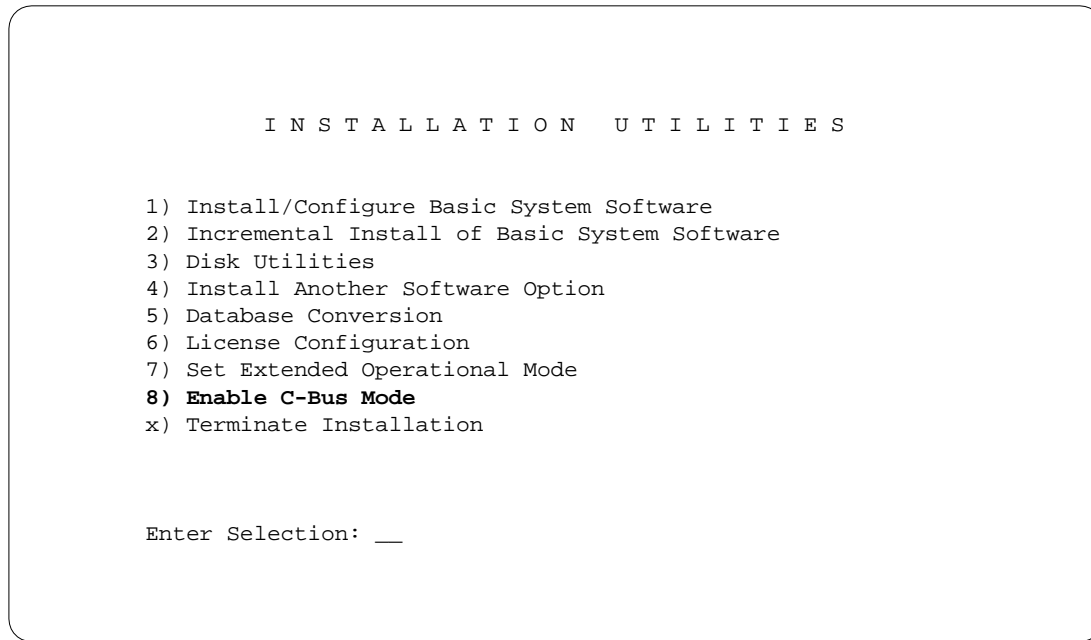
TP000006

C-bus Operational Mode requires an addition to the Installation Utilities menu as shown in *Figure 2.3*. Select **8** for the new Enable C-Bus Mode option.

Figure 2.3: Installation Utilities Screen

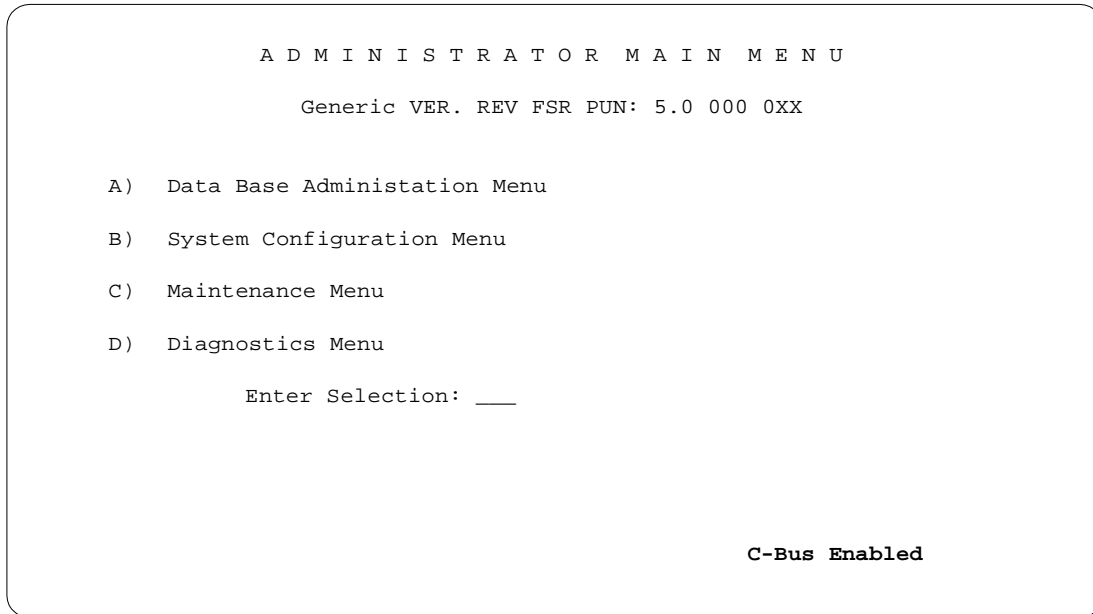
TP000003

The Administrator Main Menu screen (see *Figure 2.4*) displays a message if C-bus is enabled. If C-bus is installed and the hardware is detected, a C-Bus Enabled message appears on the lower right corner of the screen. However, in the unusual event that the hardware is not detected, a C-Bus ERROR message displays.

Figure 2.4: Administrator Main Menu Screen

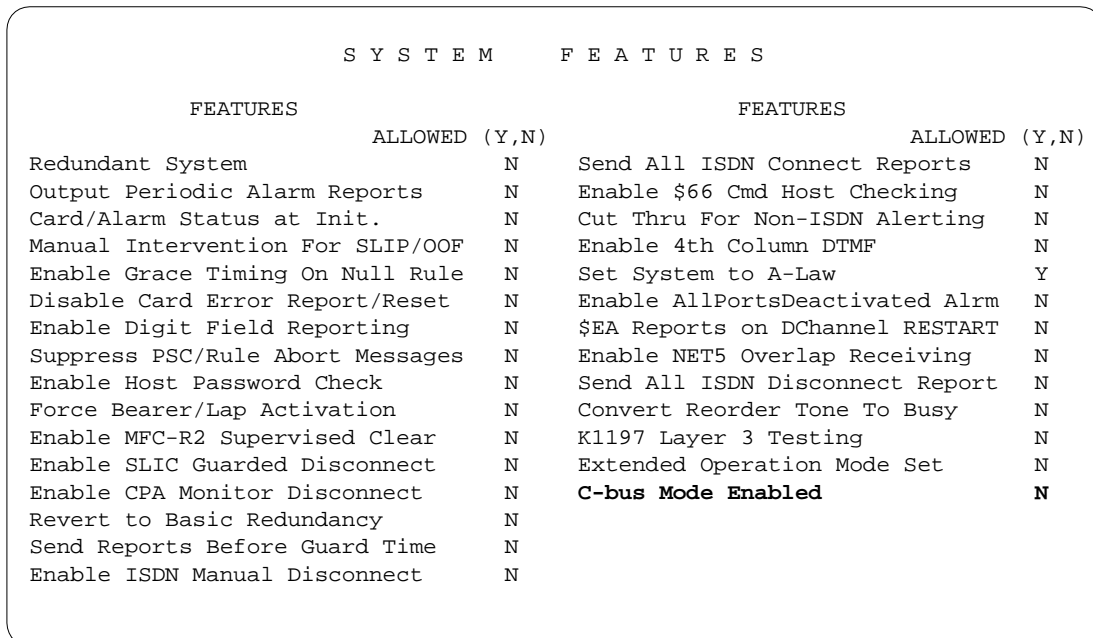
TP000089

A C-Bus Mode Enabled flag is added to the System Features screen, as shown in *Figure 2.5*. This flag is read-only and is used to verify if the C-bus is enabled. If Y, C-bus is enabled, and your switch can take advantage of the 4000 ports. If N, C-bus is disabled, and your system is limited to approximately 2000 ports.

Figure 2.5: C-bus Mode Verification Flag

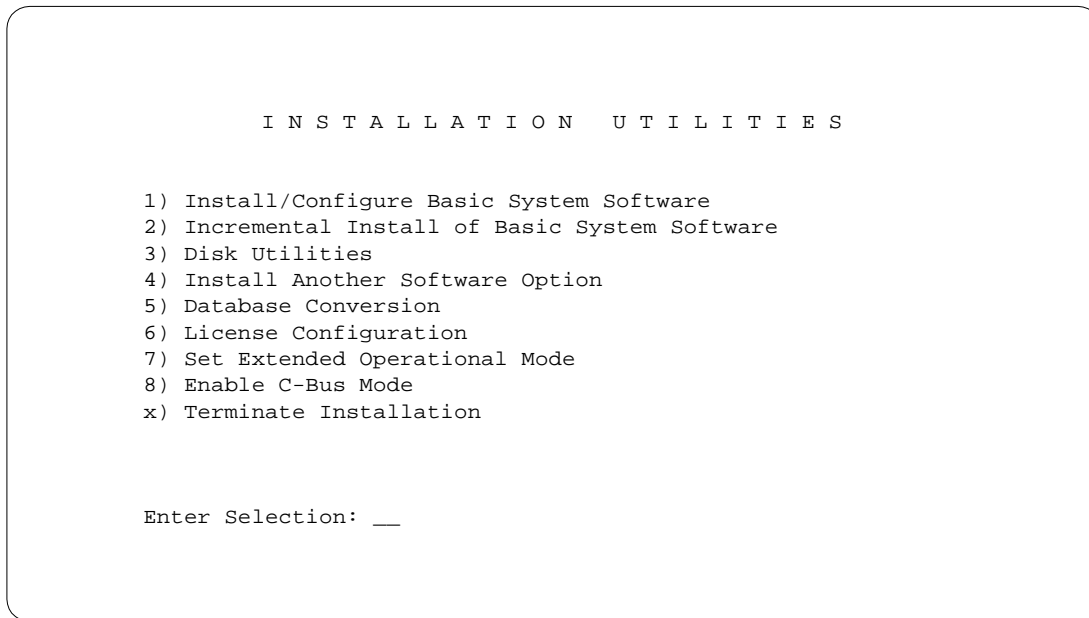
TP000004

1. Insert Disk 1 into the floppy diskette drive (A-side if this is a non-redundant system, B-side if you are returning to this procedure to install software for that side).
2. Connect or switch the administration console to the A-side CPU-TM, or go to the A-side system console.
3. Power on the A-side.
4. After the system performs diagnostic tests, the Installation Utilities menu appears (*Figure 4.1*).
5. The cursor is located in the Enter Selection data entry field. Type **2**, (for Incremental Install of Basic System Software) then press **Return**.

Figure 4.1: Installation Utilities Menu

When the installation is complete, the Installation Utilities menu appears again (Figure 4.1).

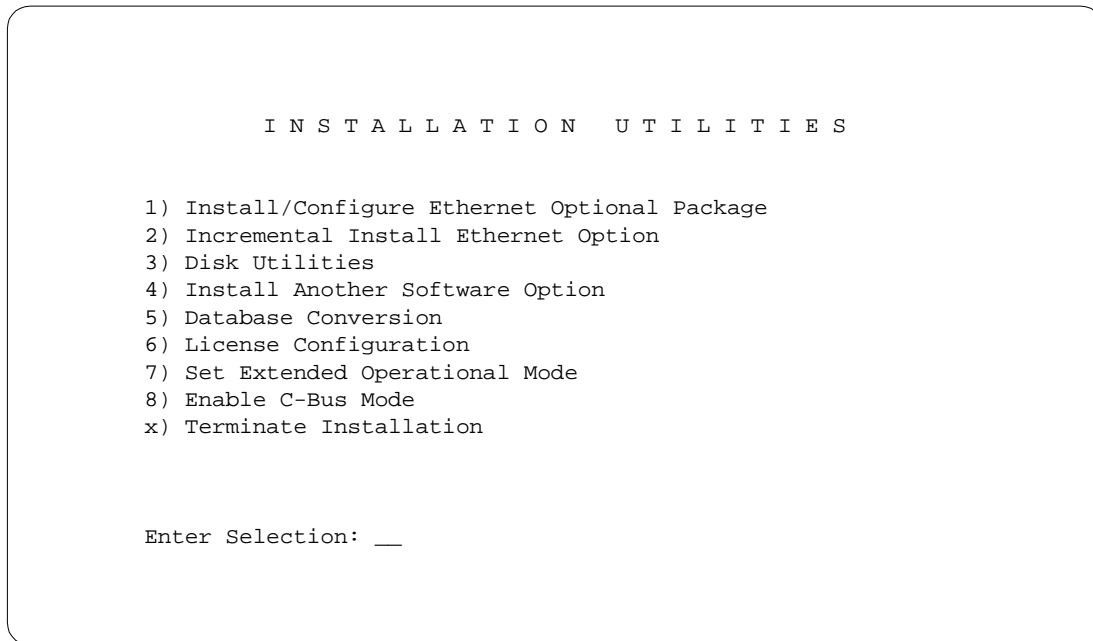
TP000070

1. Insert the Ethernet software diskette and press the **Return** key. After the system loads the Ethernet files from the diskette, the Ethernet Installation Utilities menu appears with the cursor located in the Enter Selection field (see *Figure 4.2*).

Figure 4.2: Ethernet Installation Utilities Menu

Type **6** to exit and press **Return**. The Installation Utilities screen appears (see *Figure 4.2*).

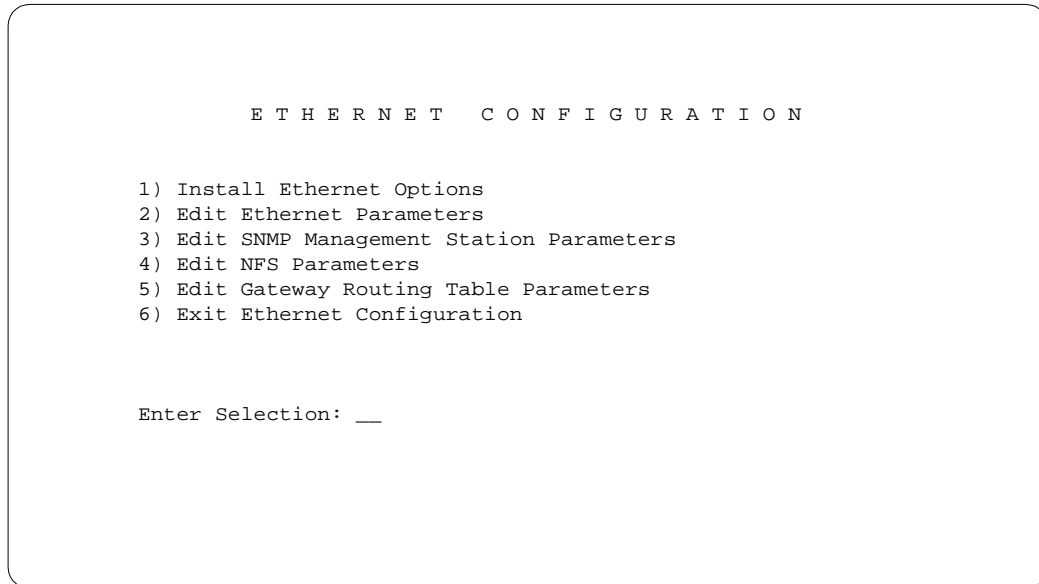
TP000019

The Ethernet Configuration menu appears (see *Figure 4.3*).

Figure 4.3: Ethernet Configuration Menu
