**ANSI Integrated SS7 ISUP,
V3.0 FSR02, Release Notes**

61090302133-0AR

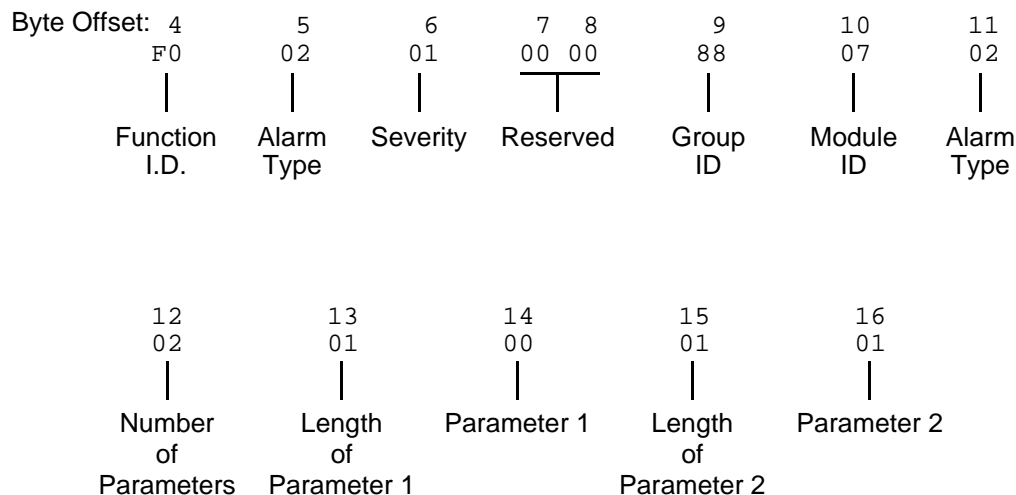
Cktint sends SS7 Alarm Condition \$F0 reports to the host indicating these system alarms are being generated, including type and severity. This enhancement allows the host the flexibility to take corrective action from a remote facility.

A new feature flag, -FEATURE_FLAG 06, causes the MTP link alarms to be processed by cktint and an \$F0 alarm report to be sent to the host.

The following is an example of the SS7 \$F0 report format:

For detailed information on the SS7 Alarm Condition \$F0 Report, see the *ANSI Integrated SS7, V3.0, System Supplement*.

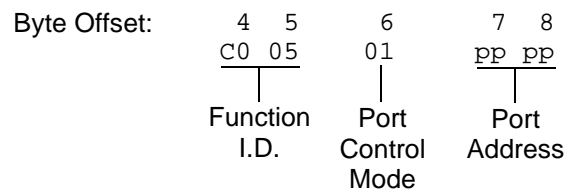
The SS7 \$C0 05 command allows a host process to relinquish control of a call assigned to itself, or assume control of a call that has been assigned to a different host.

The following is an example of the SS7 \$C0 05 command format:

For detailed information on the SS7 Host Assume/Relinquish Port Control \$C0 05 command, see the *ANSI Integrated SS7, V3.0, System Supplement*.

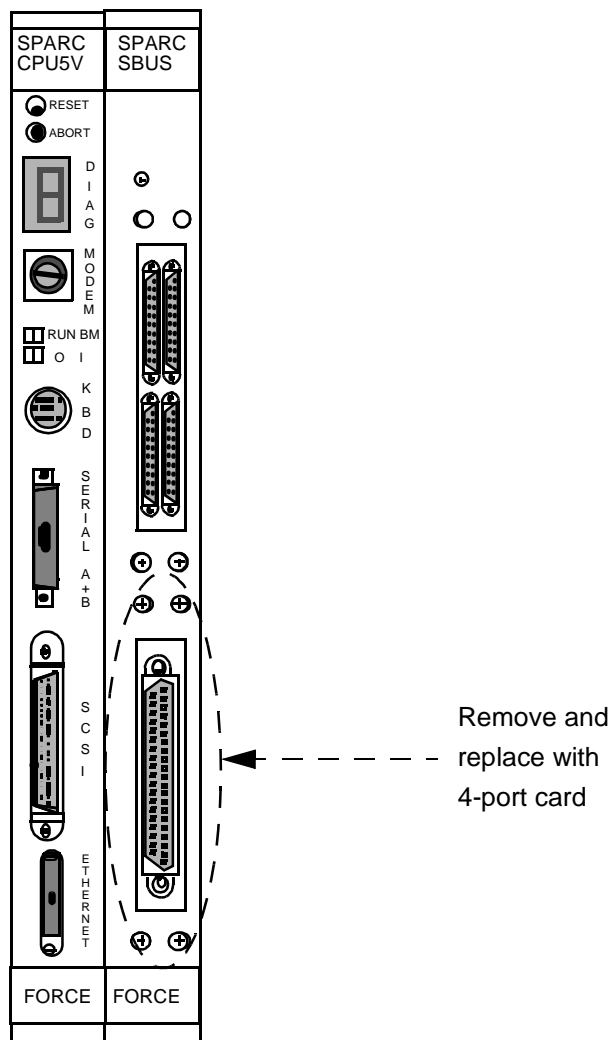
Figure 1.1: 4-link Sbus

Hardware installation requires removing the modem card in the Sbus assembly (see Figure 1.1) and replacing it with a 4-port card (see Figure 1.2). Then, follow the directions in the *ANSI Integrated SS7, V3.0, System Supplement* for attaching the additional SS7 network link cables.

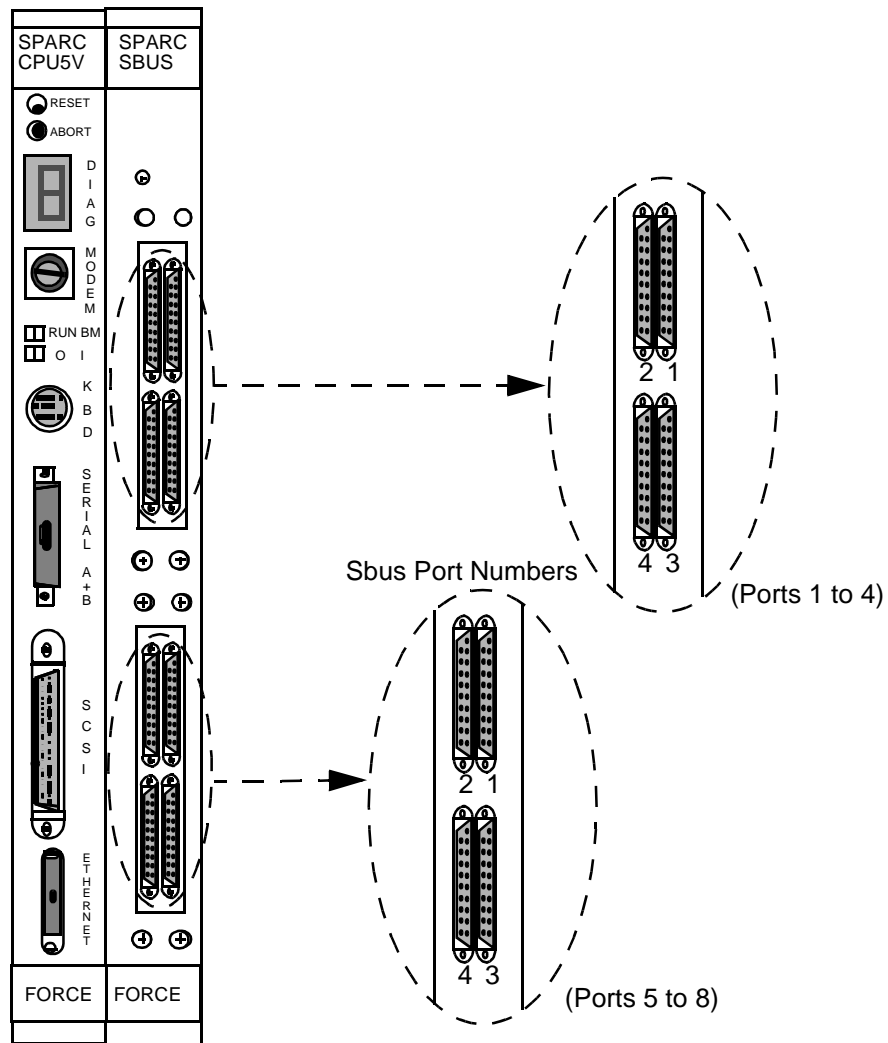
Figure 1.2: 8-link Sbus

V3.0 FSR02 is enhanced to support eight SS7 network links from the SPARC CPU5V/Sbus assembly. The additional four ports replace the current modem card in the Sbus assembly.

After the hardware installation, you must modify the MTP Level 2 Provisioning part of the MTP configuration file in **/export/home/cktint/sys/SPan (\$SPA)** to include additional links and link sets for the SS7 network links you have added. For more information, see *Section 4.3* in the *ANSI Integrated SS7, V3.0, System Supplement*.
