**CCITT Integrated SS7 ISUP,
V3.0 FSR03, Release Notes**

61090302033-0AR

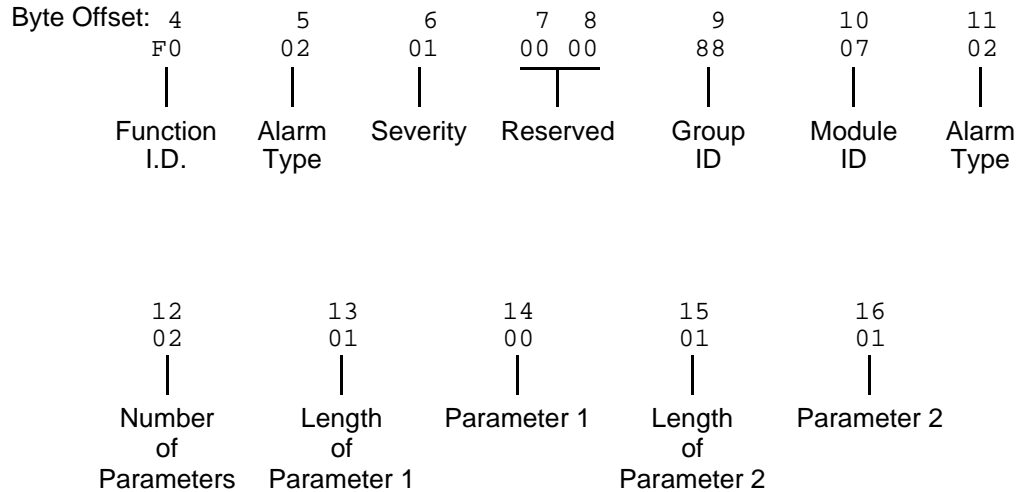
Cktint sends SS7 Alarm Condition \$F0 reports to the host indicating these system alarms are being generated, including type and severity. This enhancement allows the host the flexibility to take corrective action from a remote facility.

The following is an example of the SS7 \$F0 report format:

For detailed information on the SS7 Alarm Condition \$F0 Report, see the *CCITT Integrated SS7, V3.0, System Supplement*.

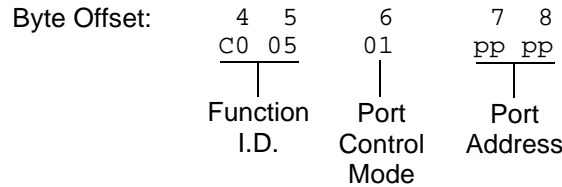
The SS7 \$C0 05 command allows a host process to relinquish control of a call assigned to itself, or assume control of a call that has been assigned to a different host.

The following is an example of the SS7 \$C0 05 command format:

For detailed information on the SS7 Host Assume/Relinquish Port Control \$C0 05 command, see the *ANSI Integrated SS7, V3.0, System Supplement*.

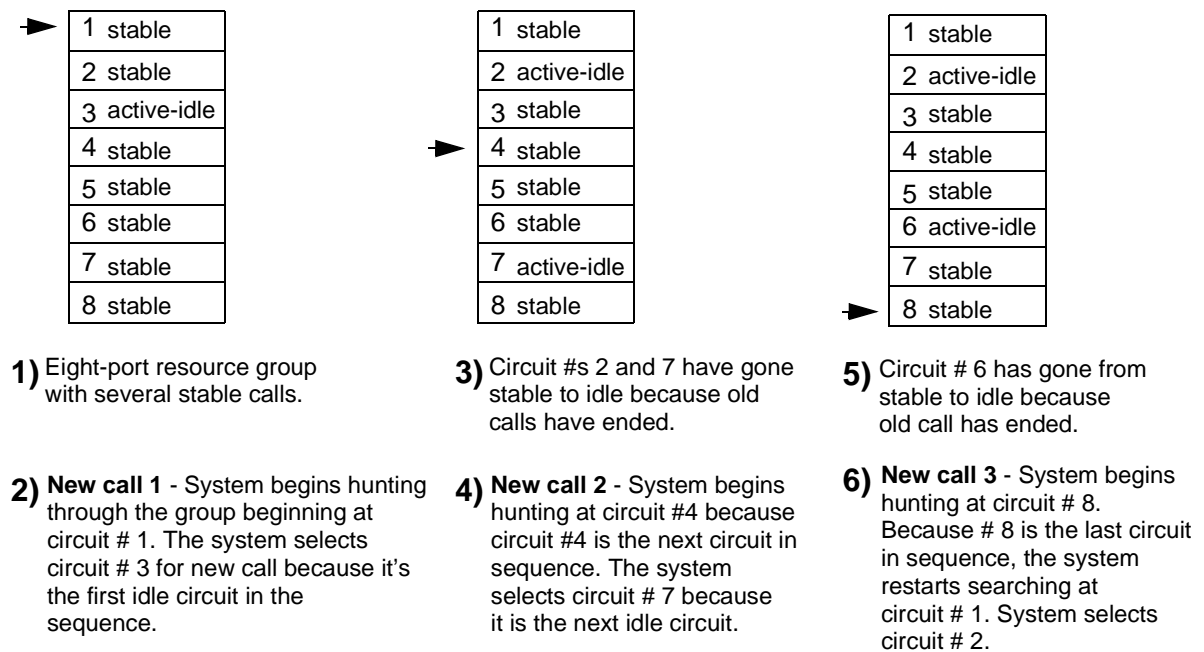
Figure 1.1: CYCLIC Hunting Example

In CYCLIC mode, the system selects the circuits from the resource group in a sequential manner; the next IDLE circuit in the group is selected for the new call. After the system has selected the last circuit in the sequence, it begins hunting from the first circuit in the group. Figure 1.1 is an example of CYCLIC mode in an eight-port resource group.

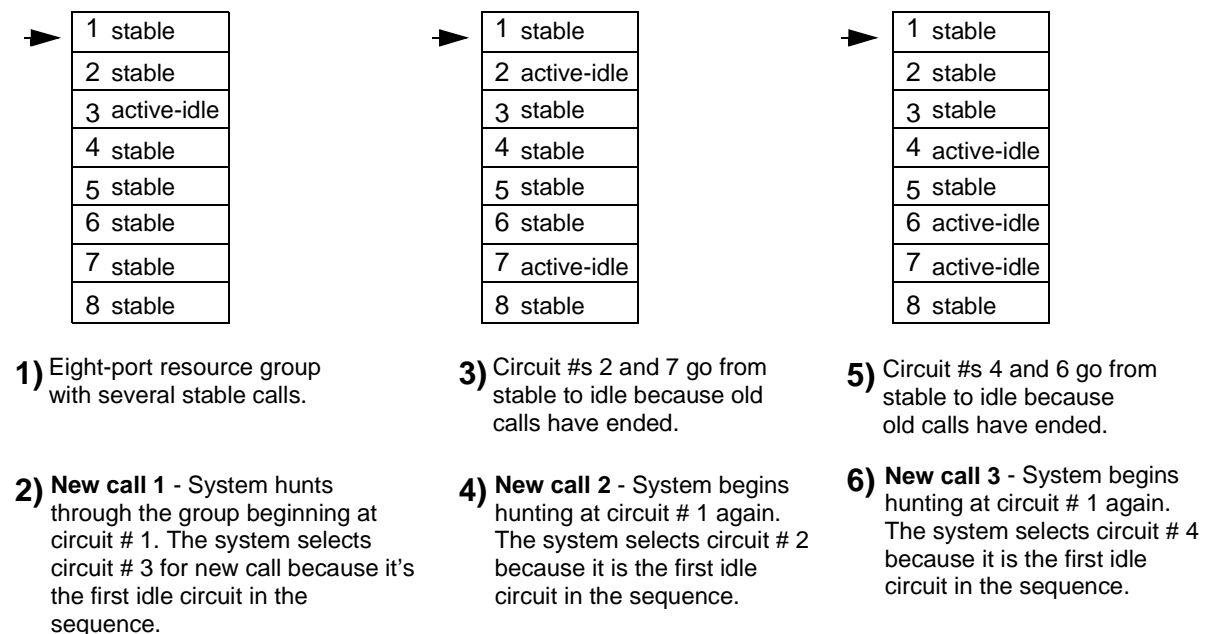
Figure 1.2: Rotary Hunting Example

In ROTARY mode, the system always begins hunting sequentially from circuit # 1. The first IDLE circuit in the sequence is always selected for the new call. Figure 1.2 is an example of ROTARY mode in an eight-port resource group.

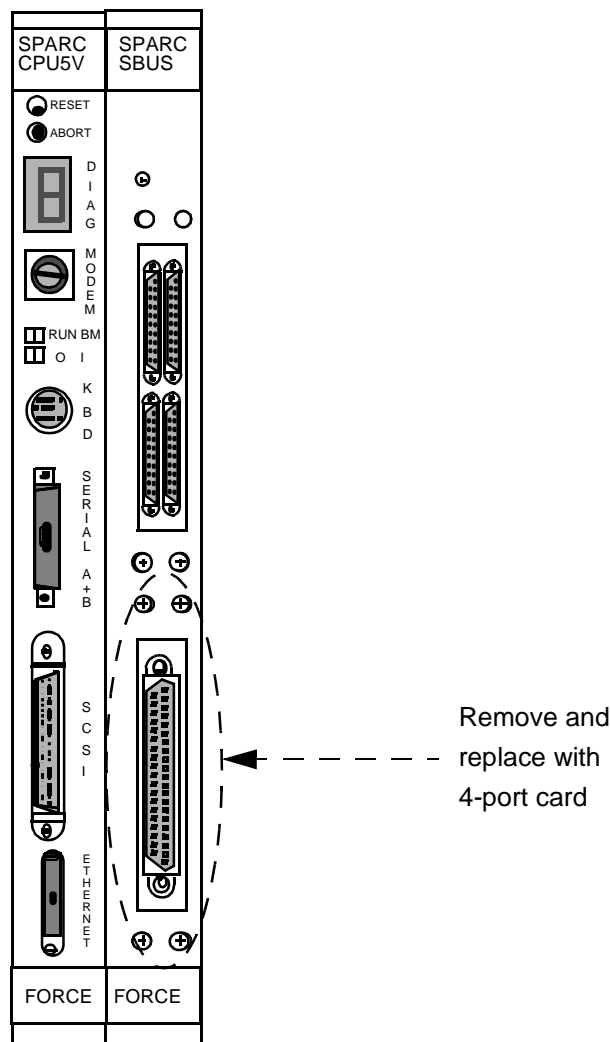
Figure 1.4: 4-link Sbus

Hardware installation requires removing the modem card in the Sbus assembly (see Figure 1.4) and replacing it with a 4-port card (see Figure 1.5). Then, follow the directions in the *CCITT Integrated SS7, V3.0, System Supplement* for attaching the additional SS7 network link cables.

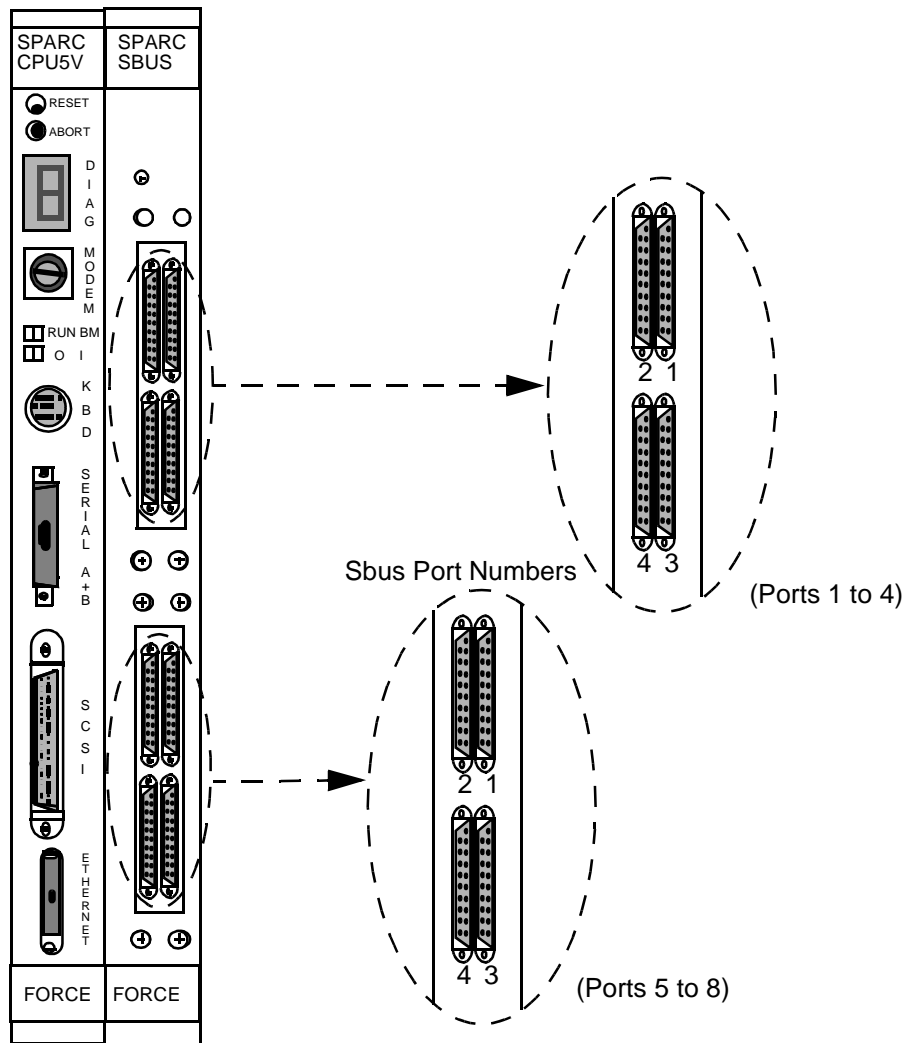
Figure 1.5: 8-link Sbus

V3.0 FSR03 is enhanced to support eight SS7 network links from the SPARC CPU5V/Sbus assembly. The additional four ports replace the current modem card in the Sbus assembly.

After the hardware installation, you must modify the MTP Level 2 Provisioning part of the MTP configuration file in `/export/home/cktint/sys/SPcc ($SPC)` to include additional links and link sets for the SS7 network links you have added. For more information, see *Section 4.3* in the *CCITT Integrated SS7, V3.0, System Supplement*.
